**MAGISTRATES COURT *of* TASMANIA**  
**CORONIAL DIVISION**

**IN THE MATTER OF AN INQUEST  
TOUCHING THE DEATH OF  
LARRY PAUL KNIGHT**

**FINDINGS, RECOMMENDATIONS AND COMMENTS of Coroner Rod  
Chandler following an inquest held in Launceston on 22 July to 25  
September and 11 November 2008.**

**26 February 2009**

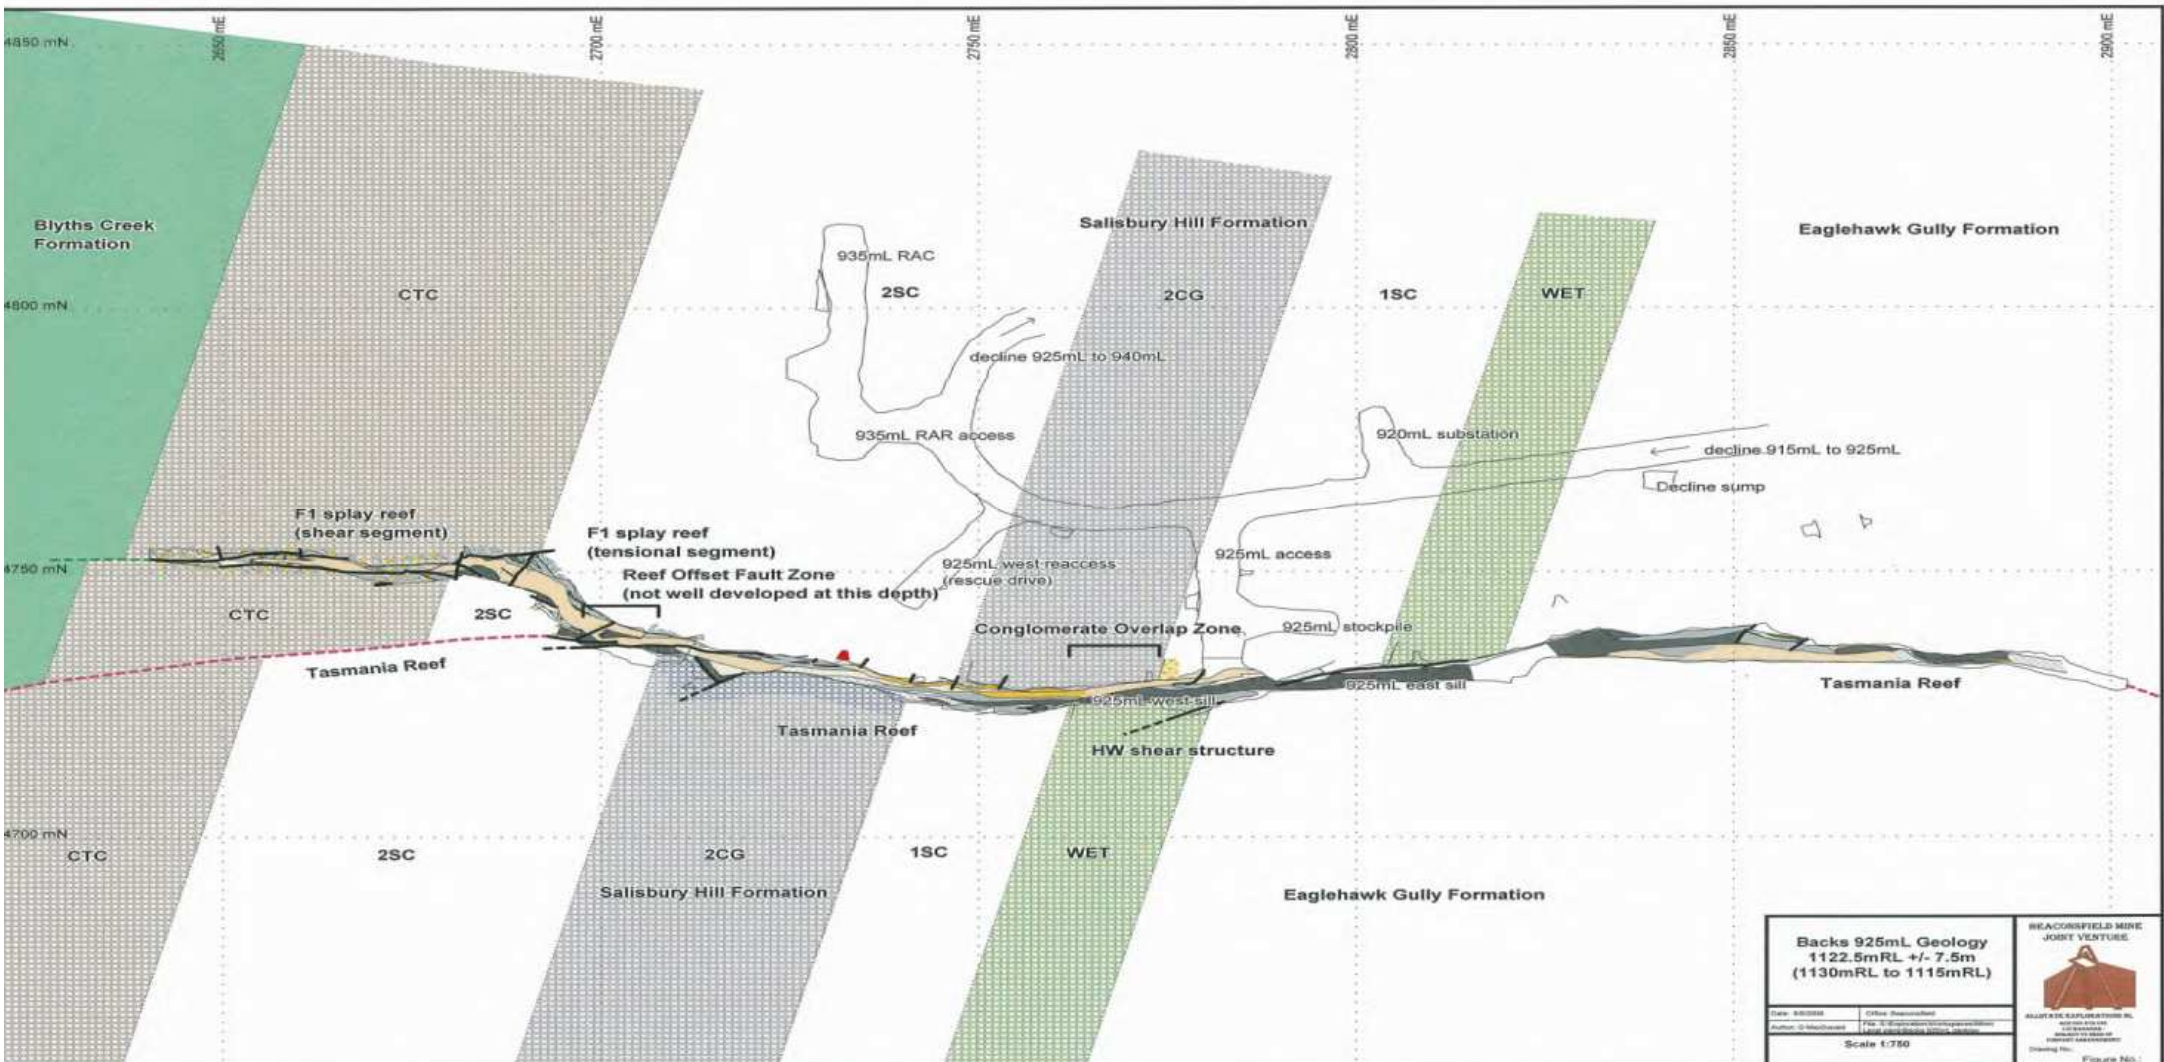
Fig. 3 depicts the geology on 925mL.

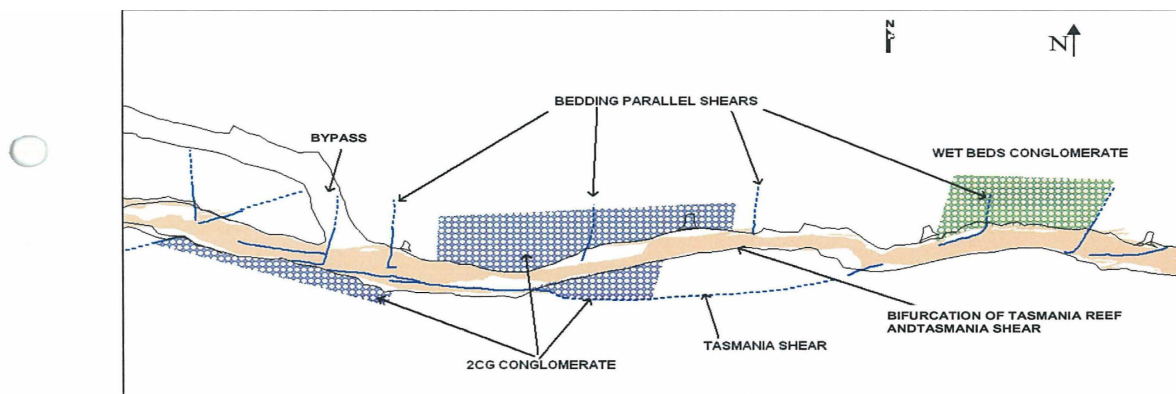
Fig. 4 depicts the structural setting of the 955 level where the departure of the reef from the Tasmania Shear hanging wall is well developed.

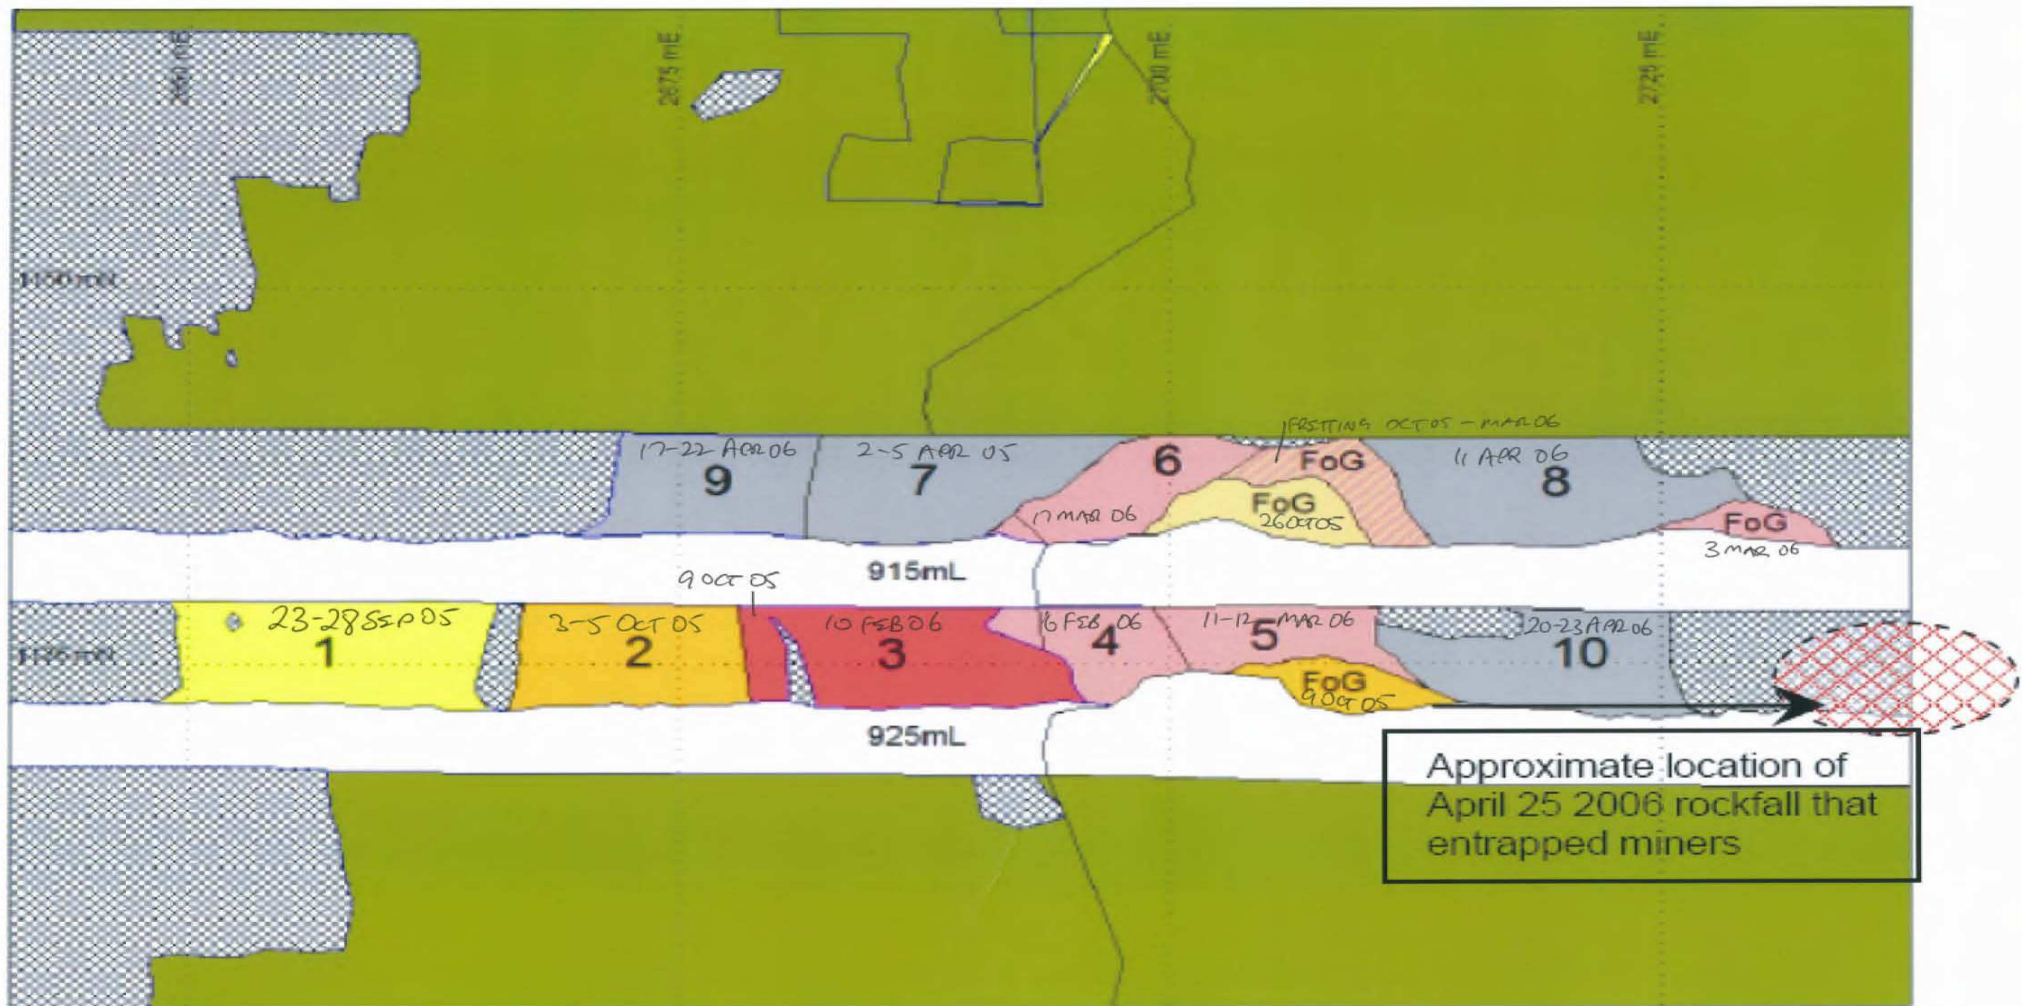
Fig. 8 illustrates the intermediate and top sills of the 940 stope block with the individually numbered stopes. The hand-written dates on the panels indicate their firing days. Note that the date on panel 7 should read 2-5 Apr 06.

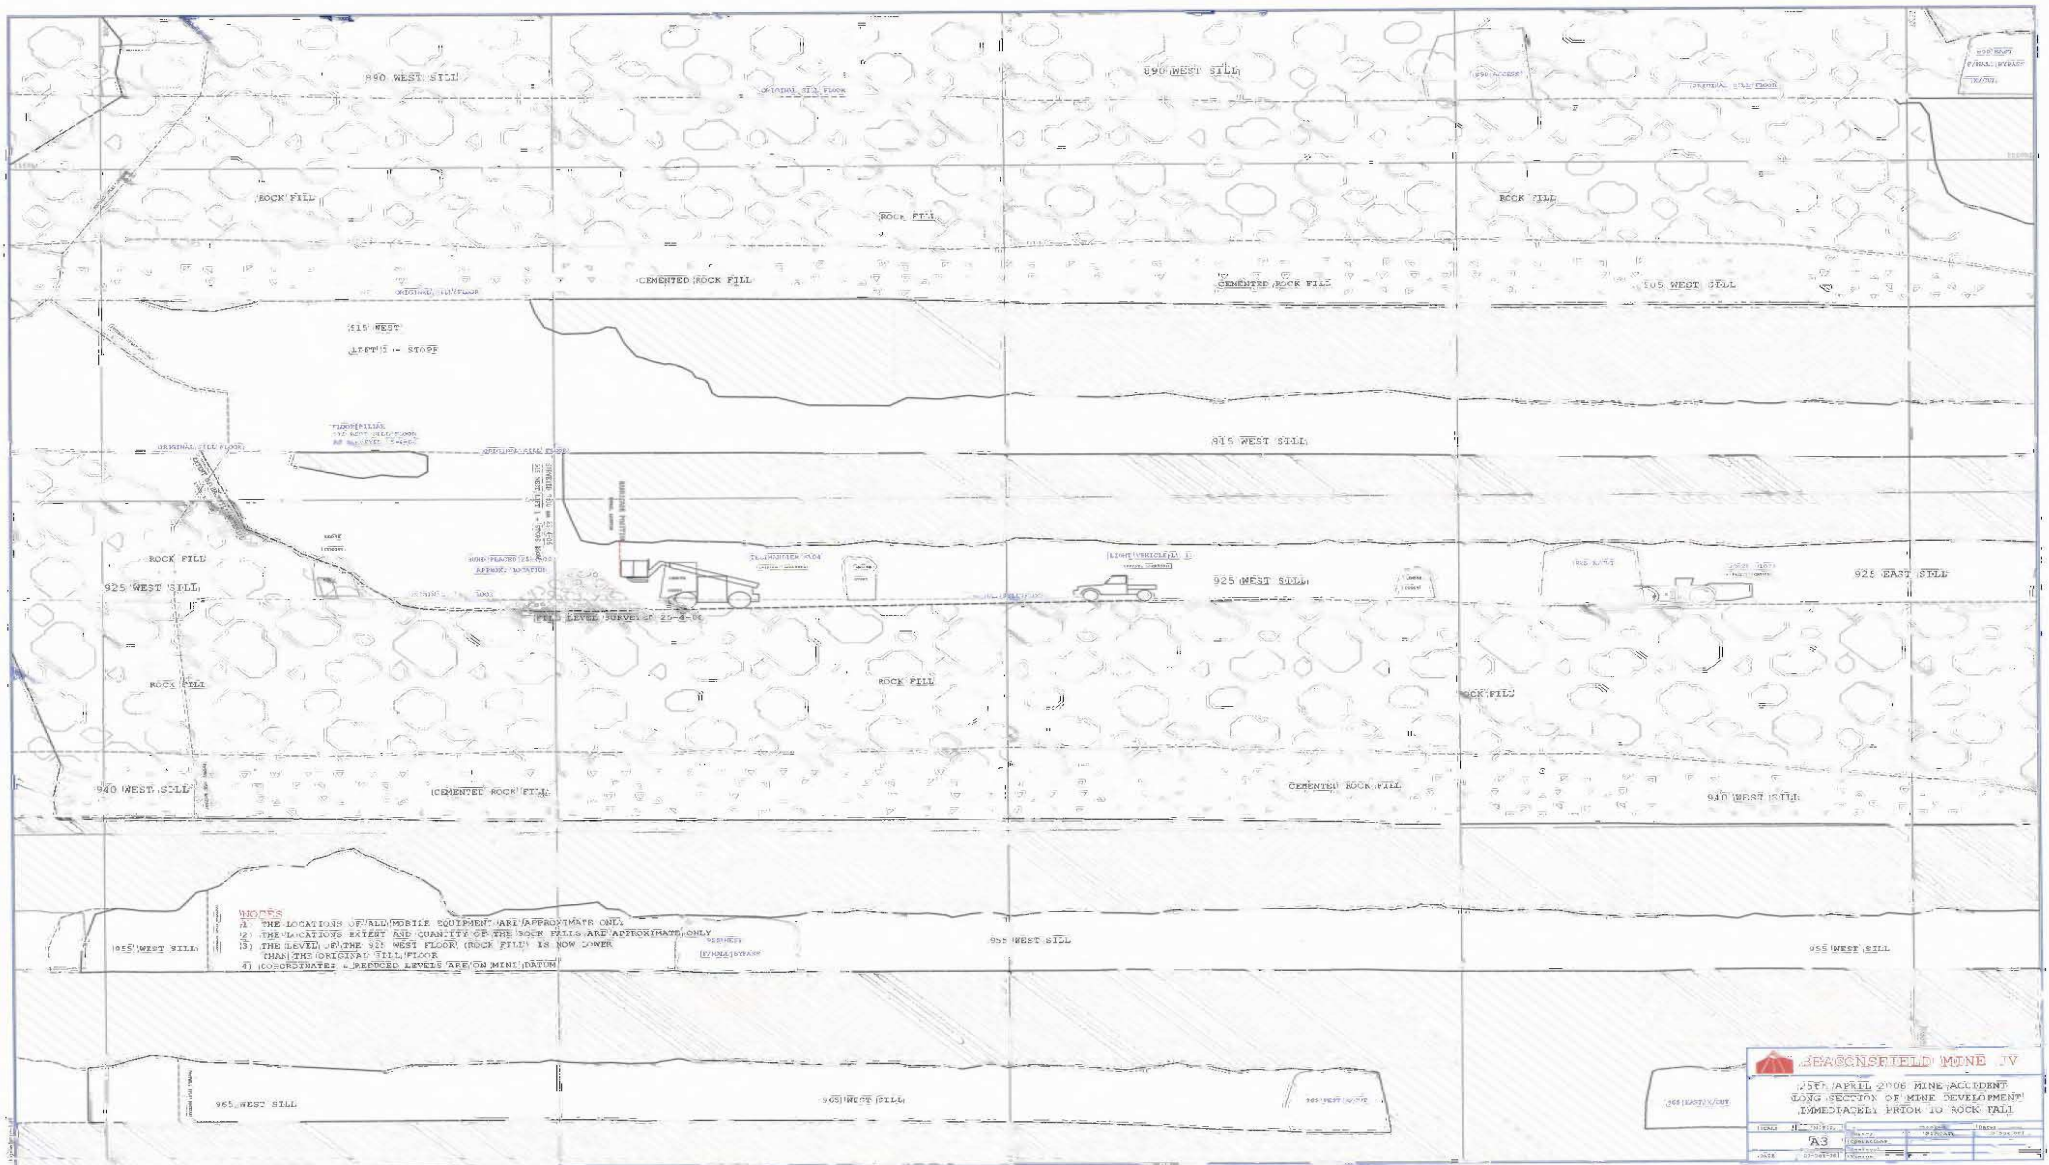
- 2.1.4. It is clear upon the evidence that at 9.23pm a local magnitude 2.3 seismic event occurred at BGM and that it caused three falls of ground within the 925m drive and another in the 915m drive. Of those in the 925m drive, the largest comprising about 800 tonnes engulfed the telehandler and caused the entrapment of Mr Russell and Mr Webb within the metal cage. The second of about 120 tonnes was smaller and occurred about 5 metres to the rear of the telehandler and in the area of a remote cuddy. The third and much smaller fall of ground occurred in the area of the access to the drive.

Fig. 9 is a long section depicting the 940 stopping block after the Anzac Day event
