BEACONSFIELD INVESTIGATION REPORT

Concerning the Incident Resulting in

The Death of Larry Knight

Which occurred at the Beaconsfield Mine

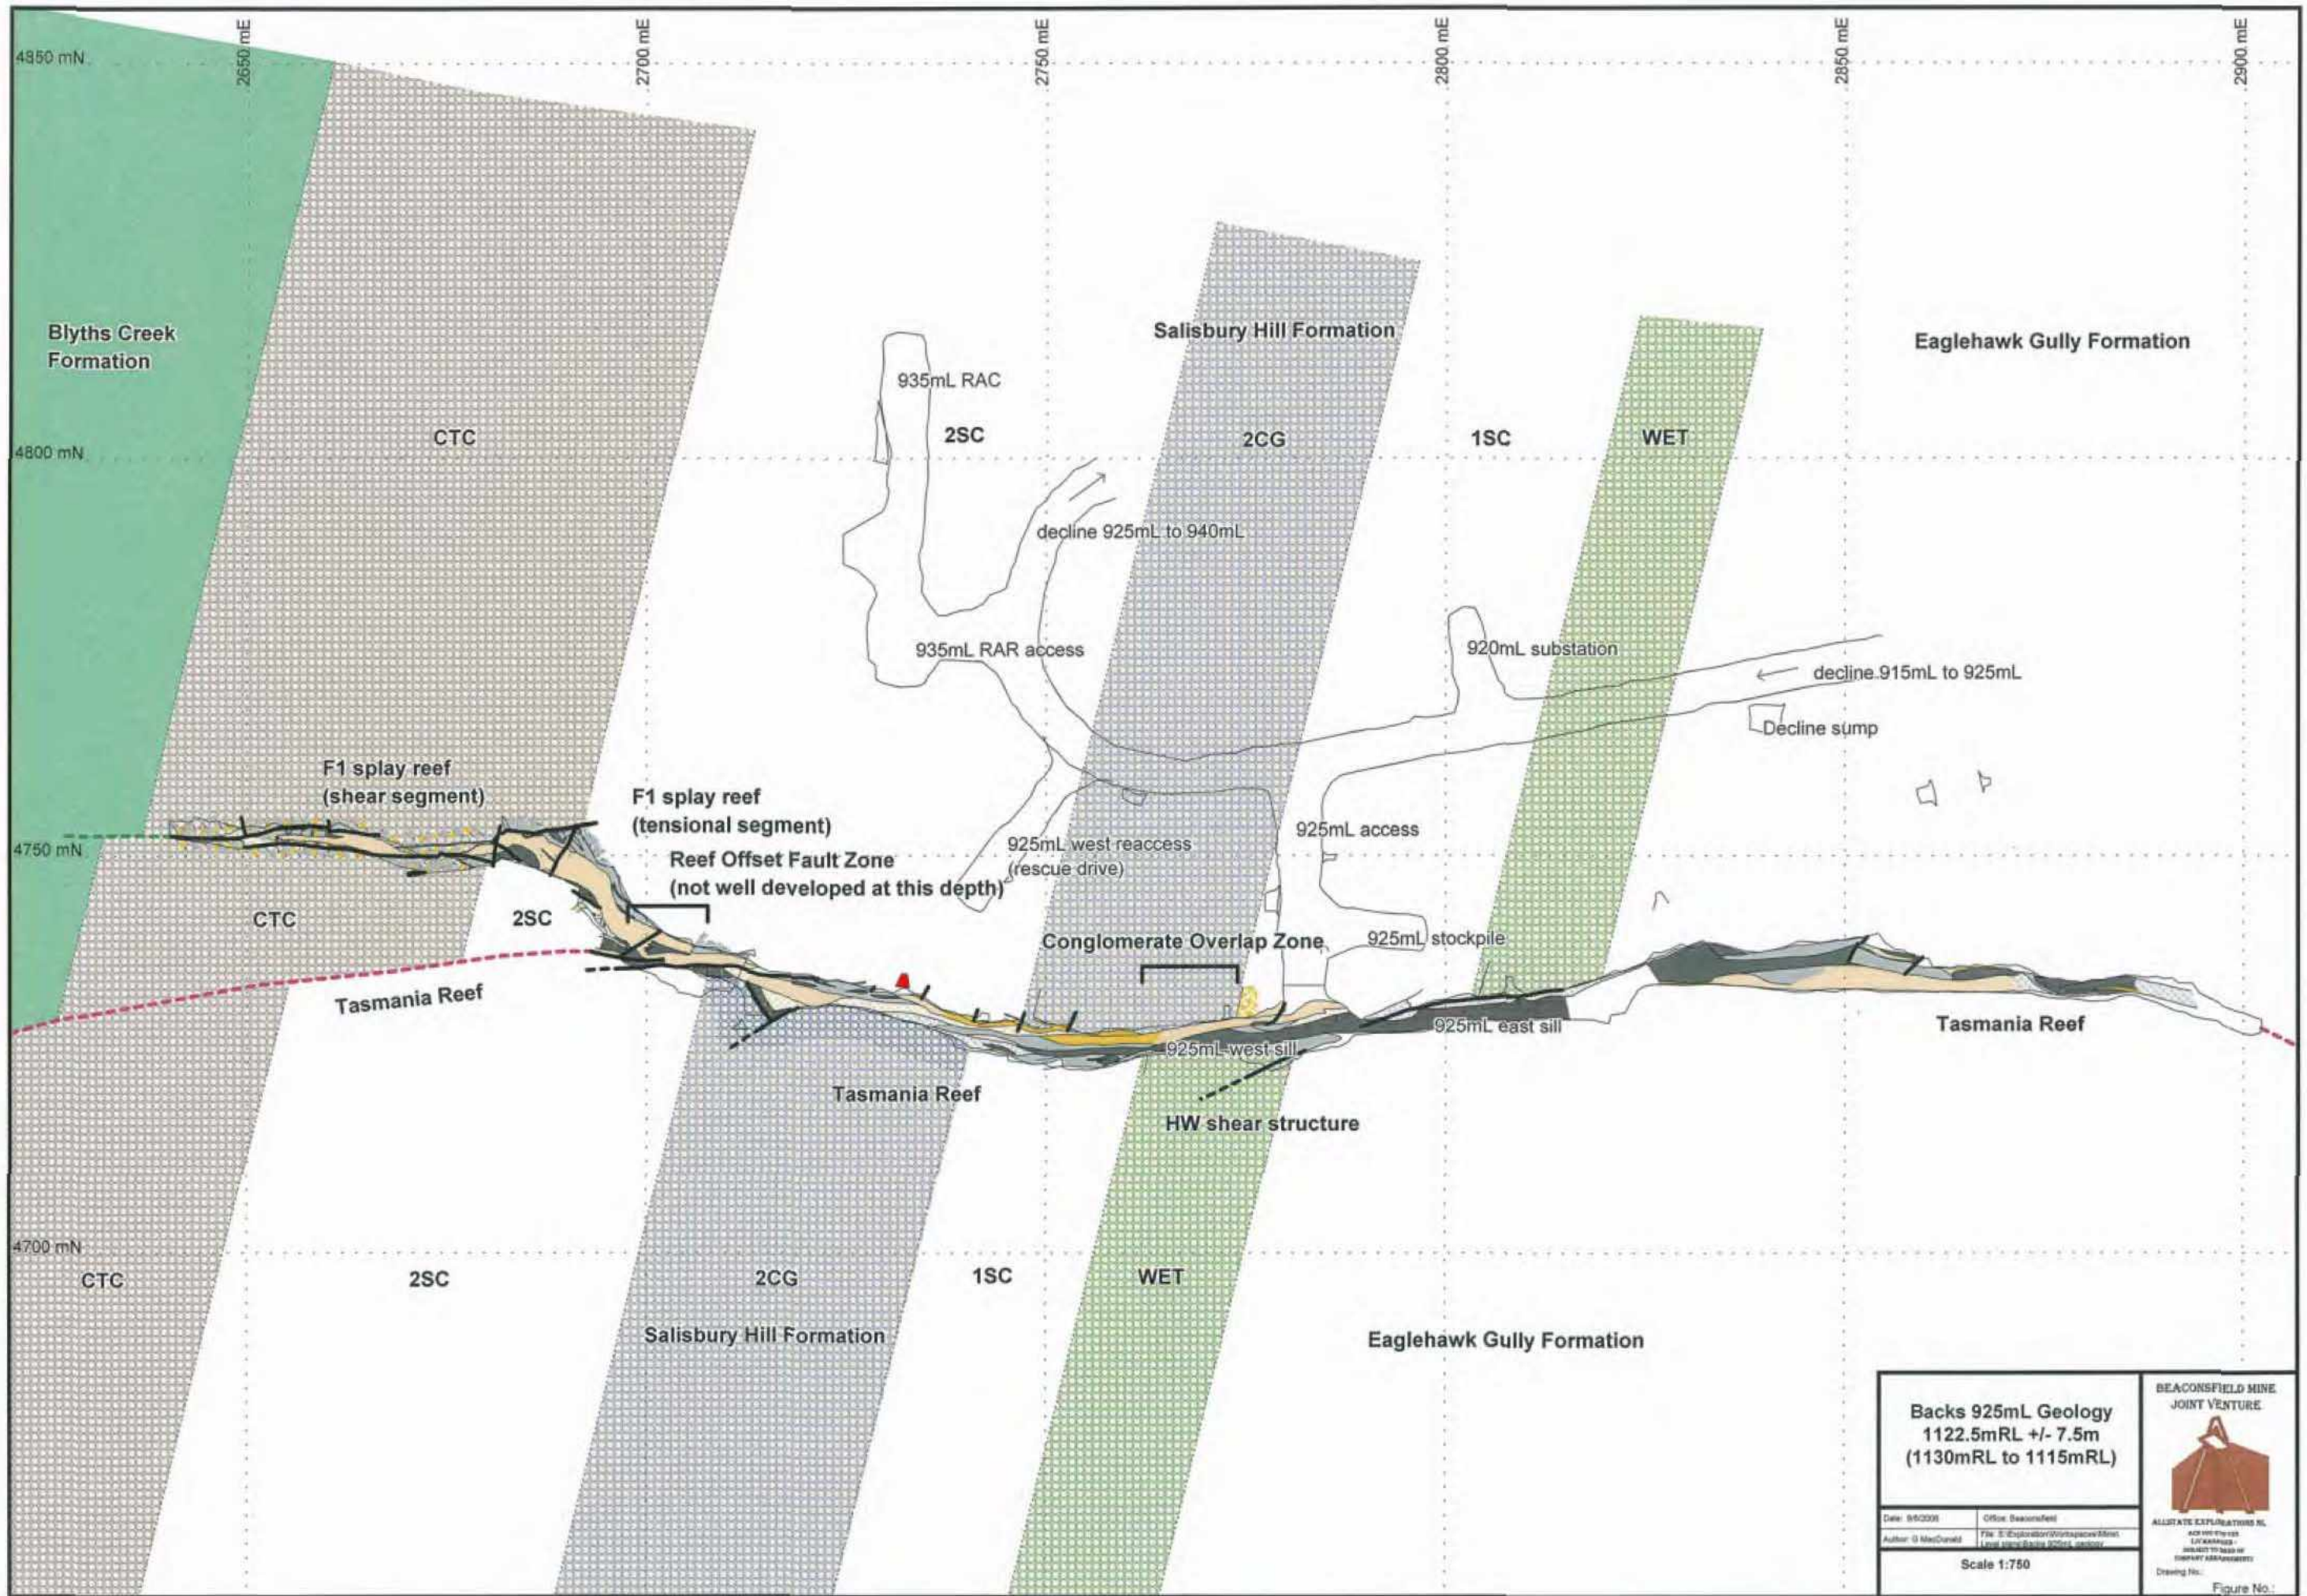
Figure 07 which appears as a fold-out page, diagrammatically represents the geology as seen as at the backs of the 925mL. CTC is the Cabbage Tree Conglomerate moving east to the 2SC, Second Sandstone and Conglomerate, then the 2CG, Second Conglomerate, then the 1SC First Sandstone and Conglomerate, and then the WET, or Wet Beds Conglomerate abutted by the Eaglehawk Gully Formation. To the west of the ore body there is the Tasmania Reef Continuation indicated by a red dotted line and it is to be noted that the ore body departs the Tasmania Reef at this junction. There is a hanging wall extension that follows the line of the Tasmania Reef continuation and it is in this area that the 2.1ML seismic event of 26 October 2005 is thought to have occurred.

There is continual seismic pressure travelling both north and south through the ore body but such forces are more readily transmitted through the stiffer conglomerate zones rather than the more yielding sandstone beds. Until the ore body is mined, those forces readily transfer through the Tasmania Reef fault, but once the ore is removed and replaced with rock fill, the reef has a damming effect on those pressures which then seep away around the mined reef. There is a build up of pressure, and hence increased seismic activity in the conglomerate overlap zone because of the tendency of the pressures to follow the conglomerate and there is also increased seismic pressure and activity where the ore body departs the Tasmania Reef fault. These areas are indicated on the diagram as the Conglomerate Overlap Zone and the Reef Offset Fault Zone.

▲ Location of April 25th rock fall

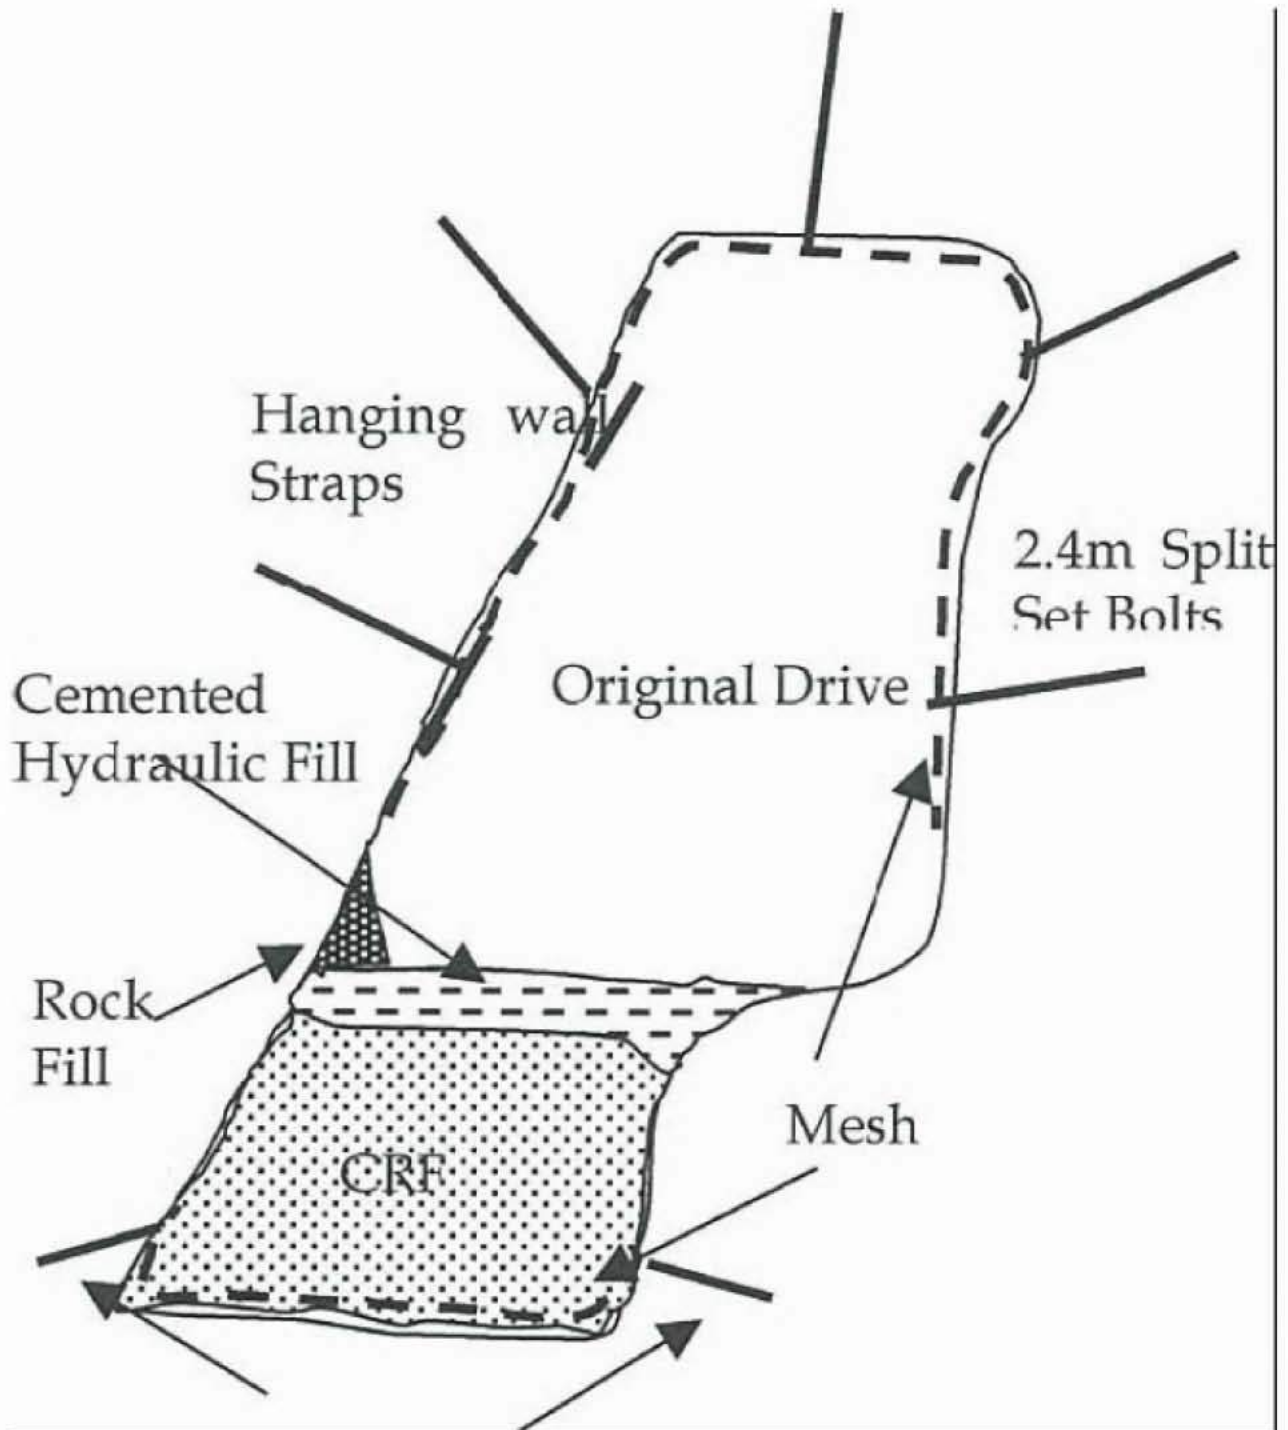
Figure 09

In figure 9 above, the dotted lines around the drive indicate the wire mesh which was held in place by straps which were in turn bolted into the rock face. The diagram refers to 2.4m Split Set Bolts, but different forms of bolts could be used. Usually the greater the length of the bolt, the greater support offered, although a relatively short bolt into solid rock would offer more support than a longer bolt placed into friable or damaged rock. Greater protection could also be afforded by the use of dynamic ground support which would allow a dynamic arch, which could cope with the events of greater seismic magnitude.

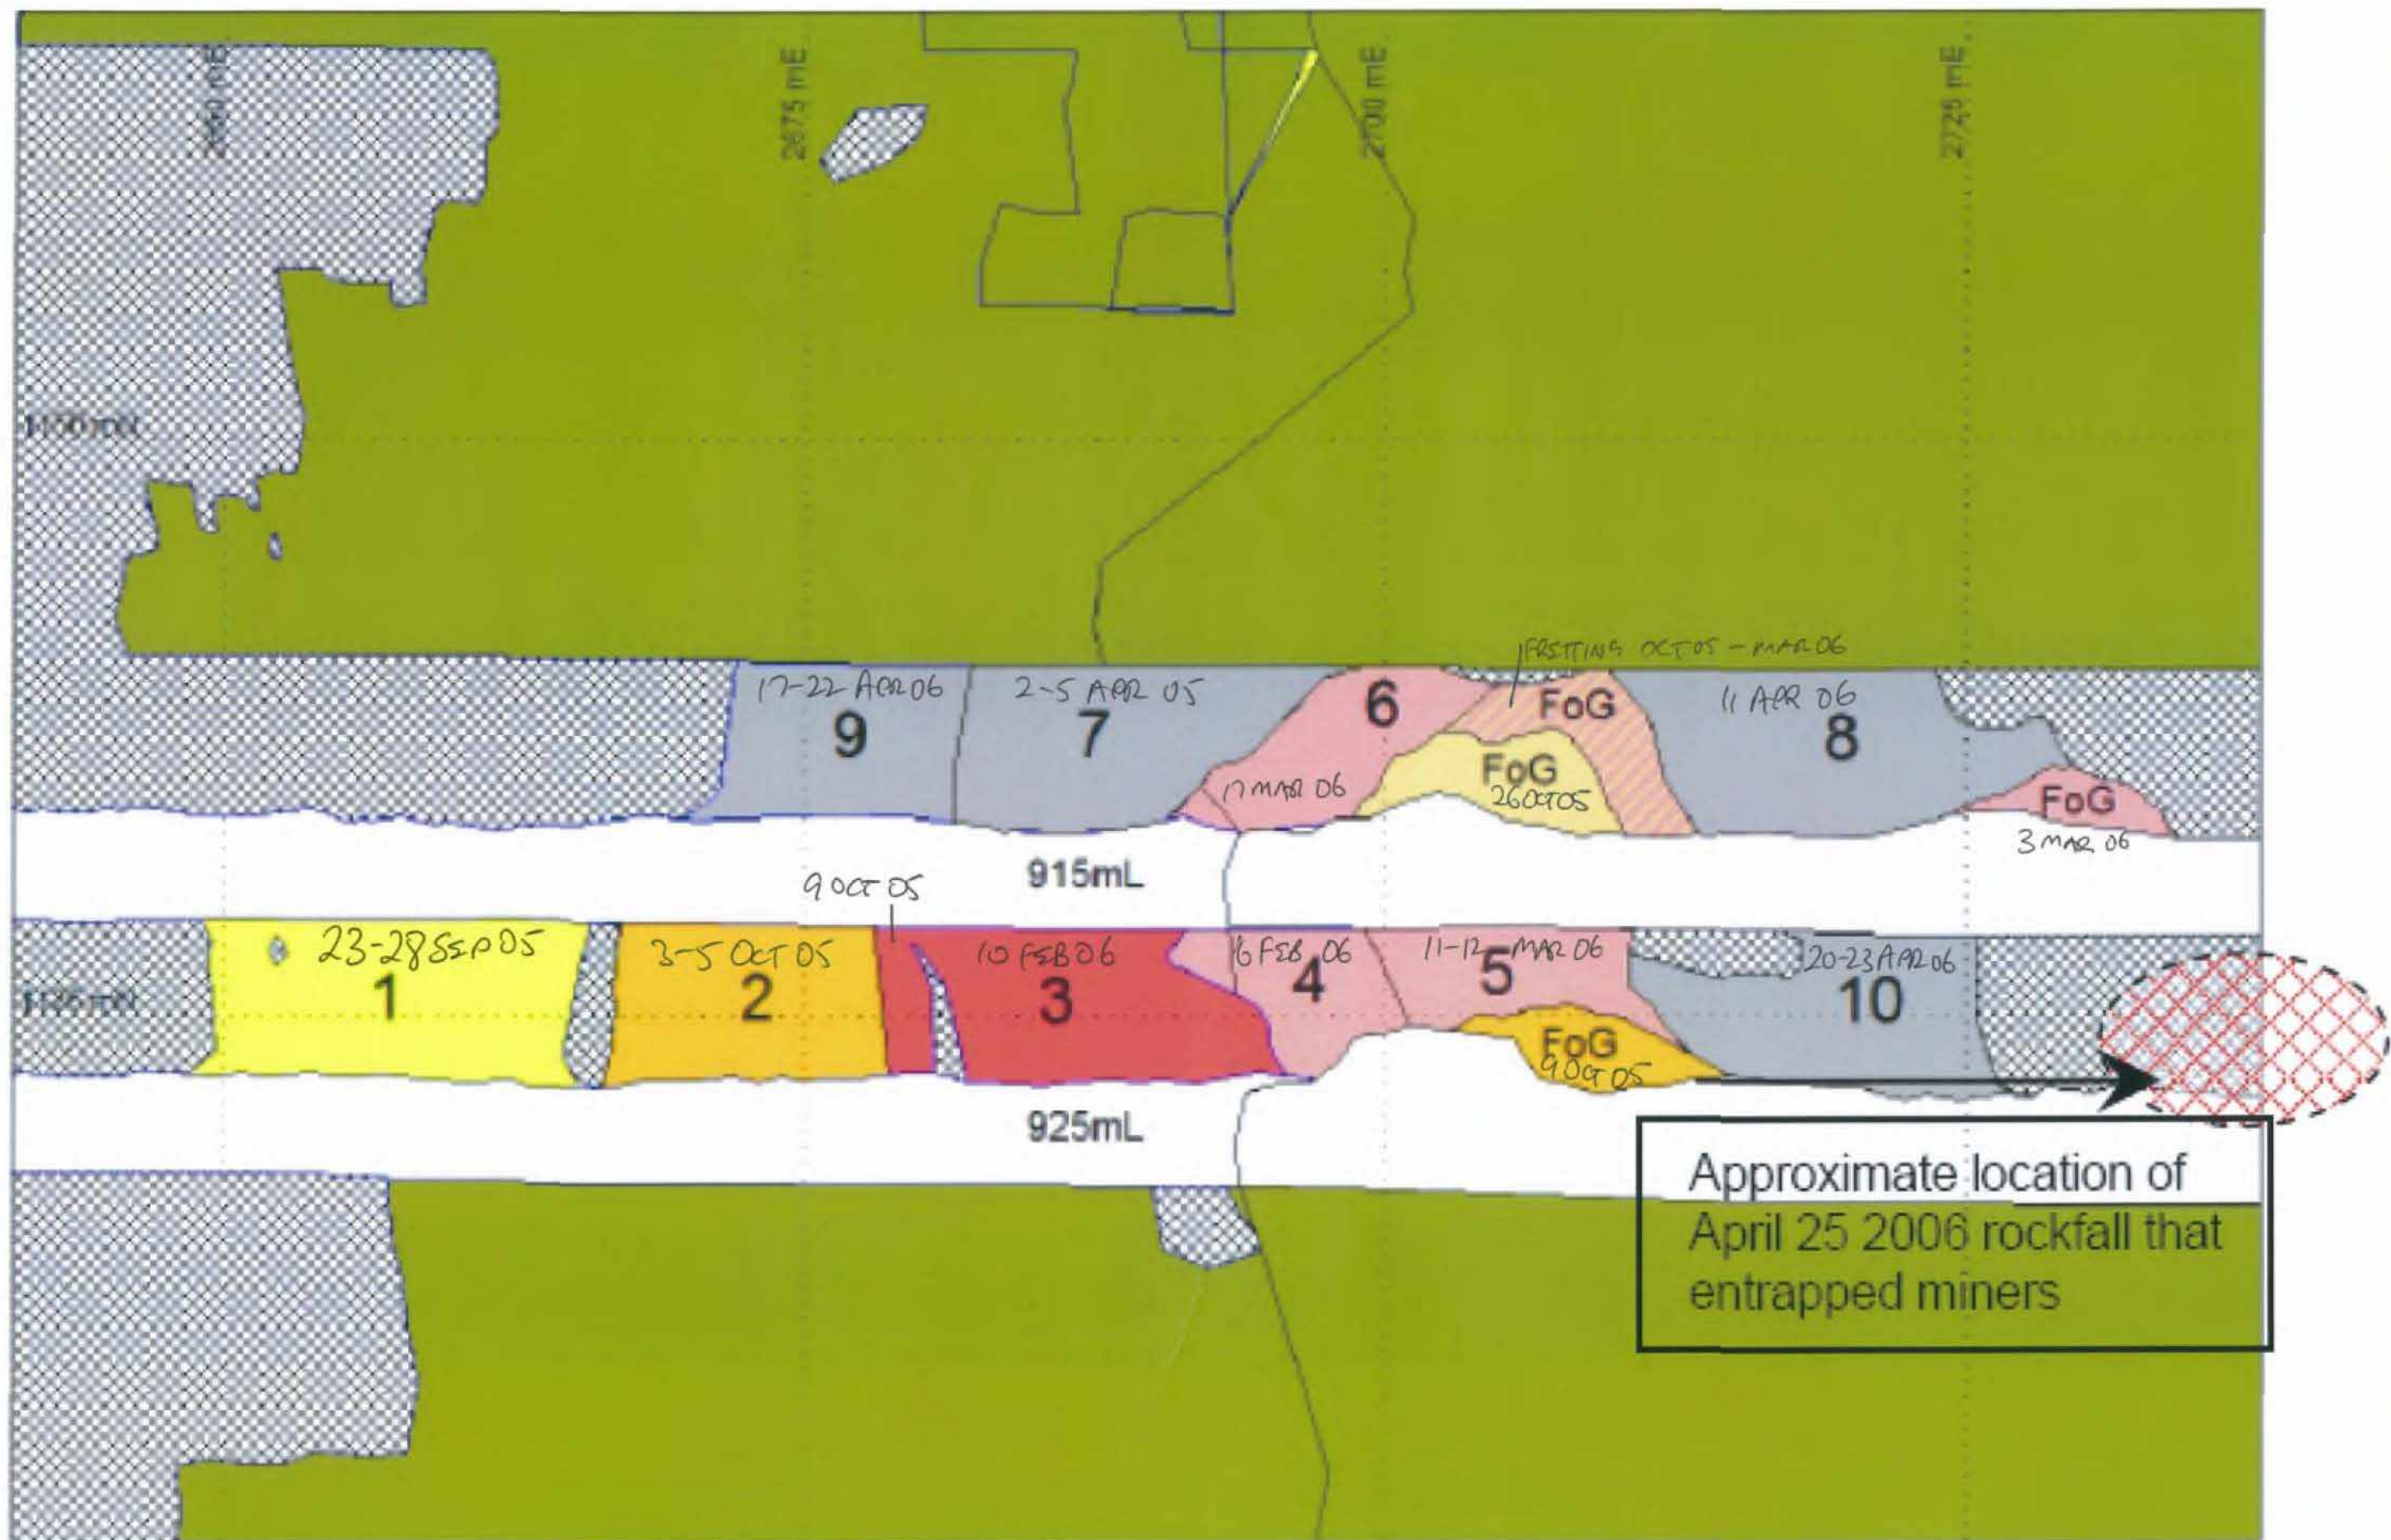
By September 2005 the bottom level of the 940mL mining block had been mined and work had commenced on the intermediate stope, being the 925mL. Foldout Figure 12 illustrates the remaining stopes to be mined on the 940mL block. Panel 1 was fired from 23 – 28th September 2005 and panel 2 from 3 – 5th October 2005. On 9th October the eastern edge of Panel 3 was fired after which there was a fall of ground beneath panel 5 on the 925mL. In the usual course of events, the entirety of the 925mL would have been mined before commencing at the western end of the 915mL. The numbering on the diagram illustrates the revised mining method adopted after the events of 26th October, and the dates within

the panels indicate when they were fired.

On 26th October there was a major seismic event of 2.1 M_L which is believed to have originated in the area of the continuation of the Tasmania Reef, to the west of the Tasmania Reef Offset Fault zone. This induced a major fall of ground on the 915mL which is illustrated in yellow on Figure 12. Both the falls of ground on 9th and 26th October involved a failure beyond the level of ground support and naturally caused great concern to the operators of BGM. Workplace Safety Tasmania (WST) were notified after both falls, mining operations ceased, and the Mines' operators sought the advice of at least five consultants, namely

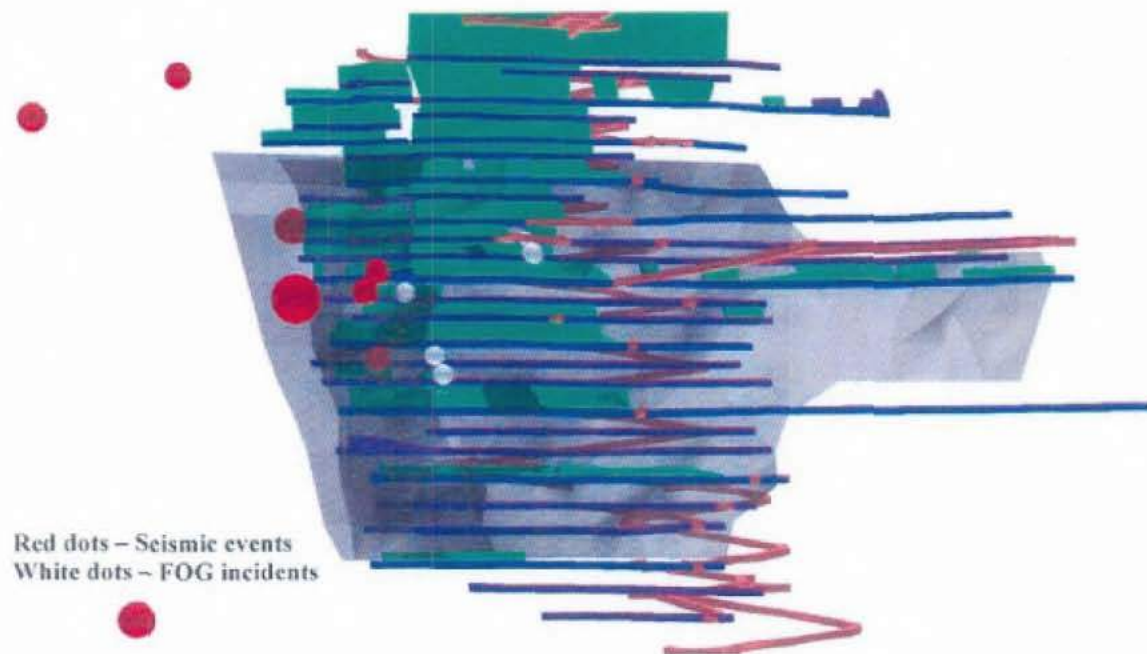
Figure 1.4 All Seismic Events with $ML > 1$ and FOG incidents recorded at Beaconsfield Mine

- *In the seismic data received (2004-06-15 to 2006-01-17), all the $ML \geq 1.0$ events plotted west of the offset fault, either on reef or in the hanging wall (red dots in Figure 1.4)*
- *7 Fall of Ground (“FOG”) incidents were provided to AMC and 5 of them occurred close to an area where stoping broke away from the main reef on one of the Off-set Faults splays (white dots in Figure 1.4)*

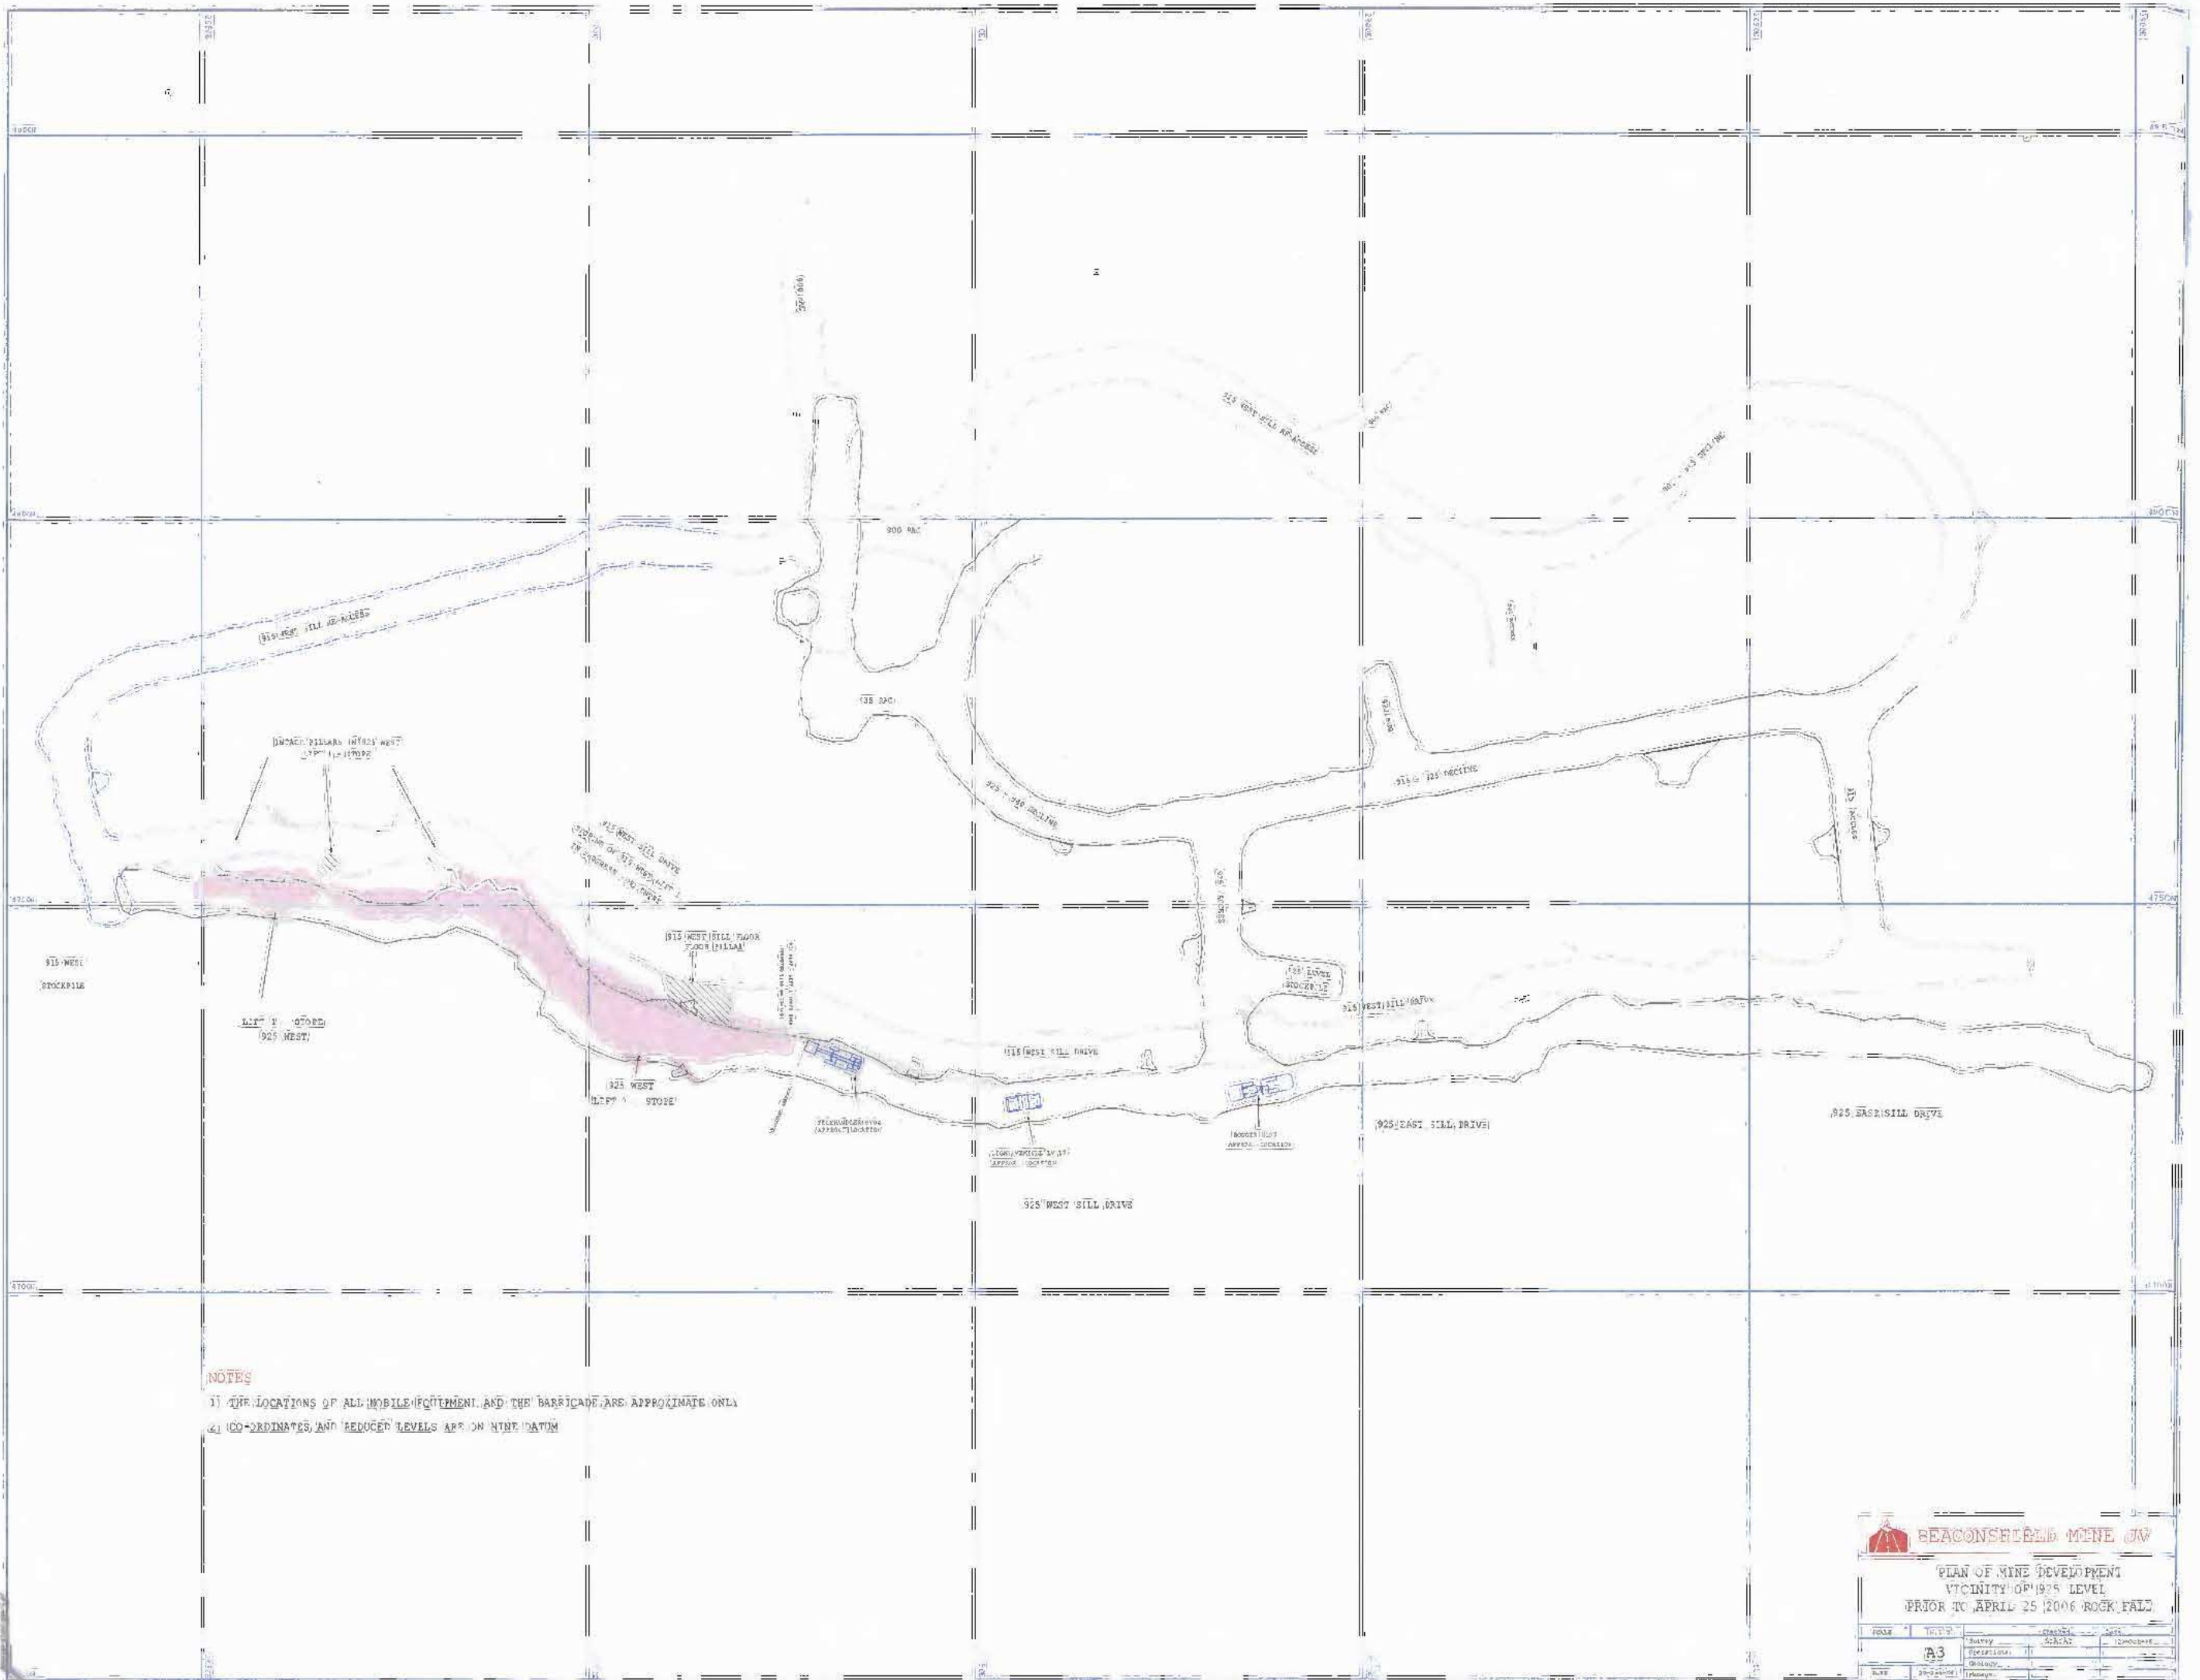
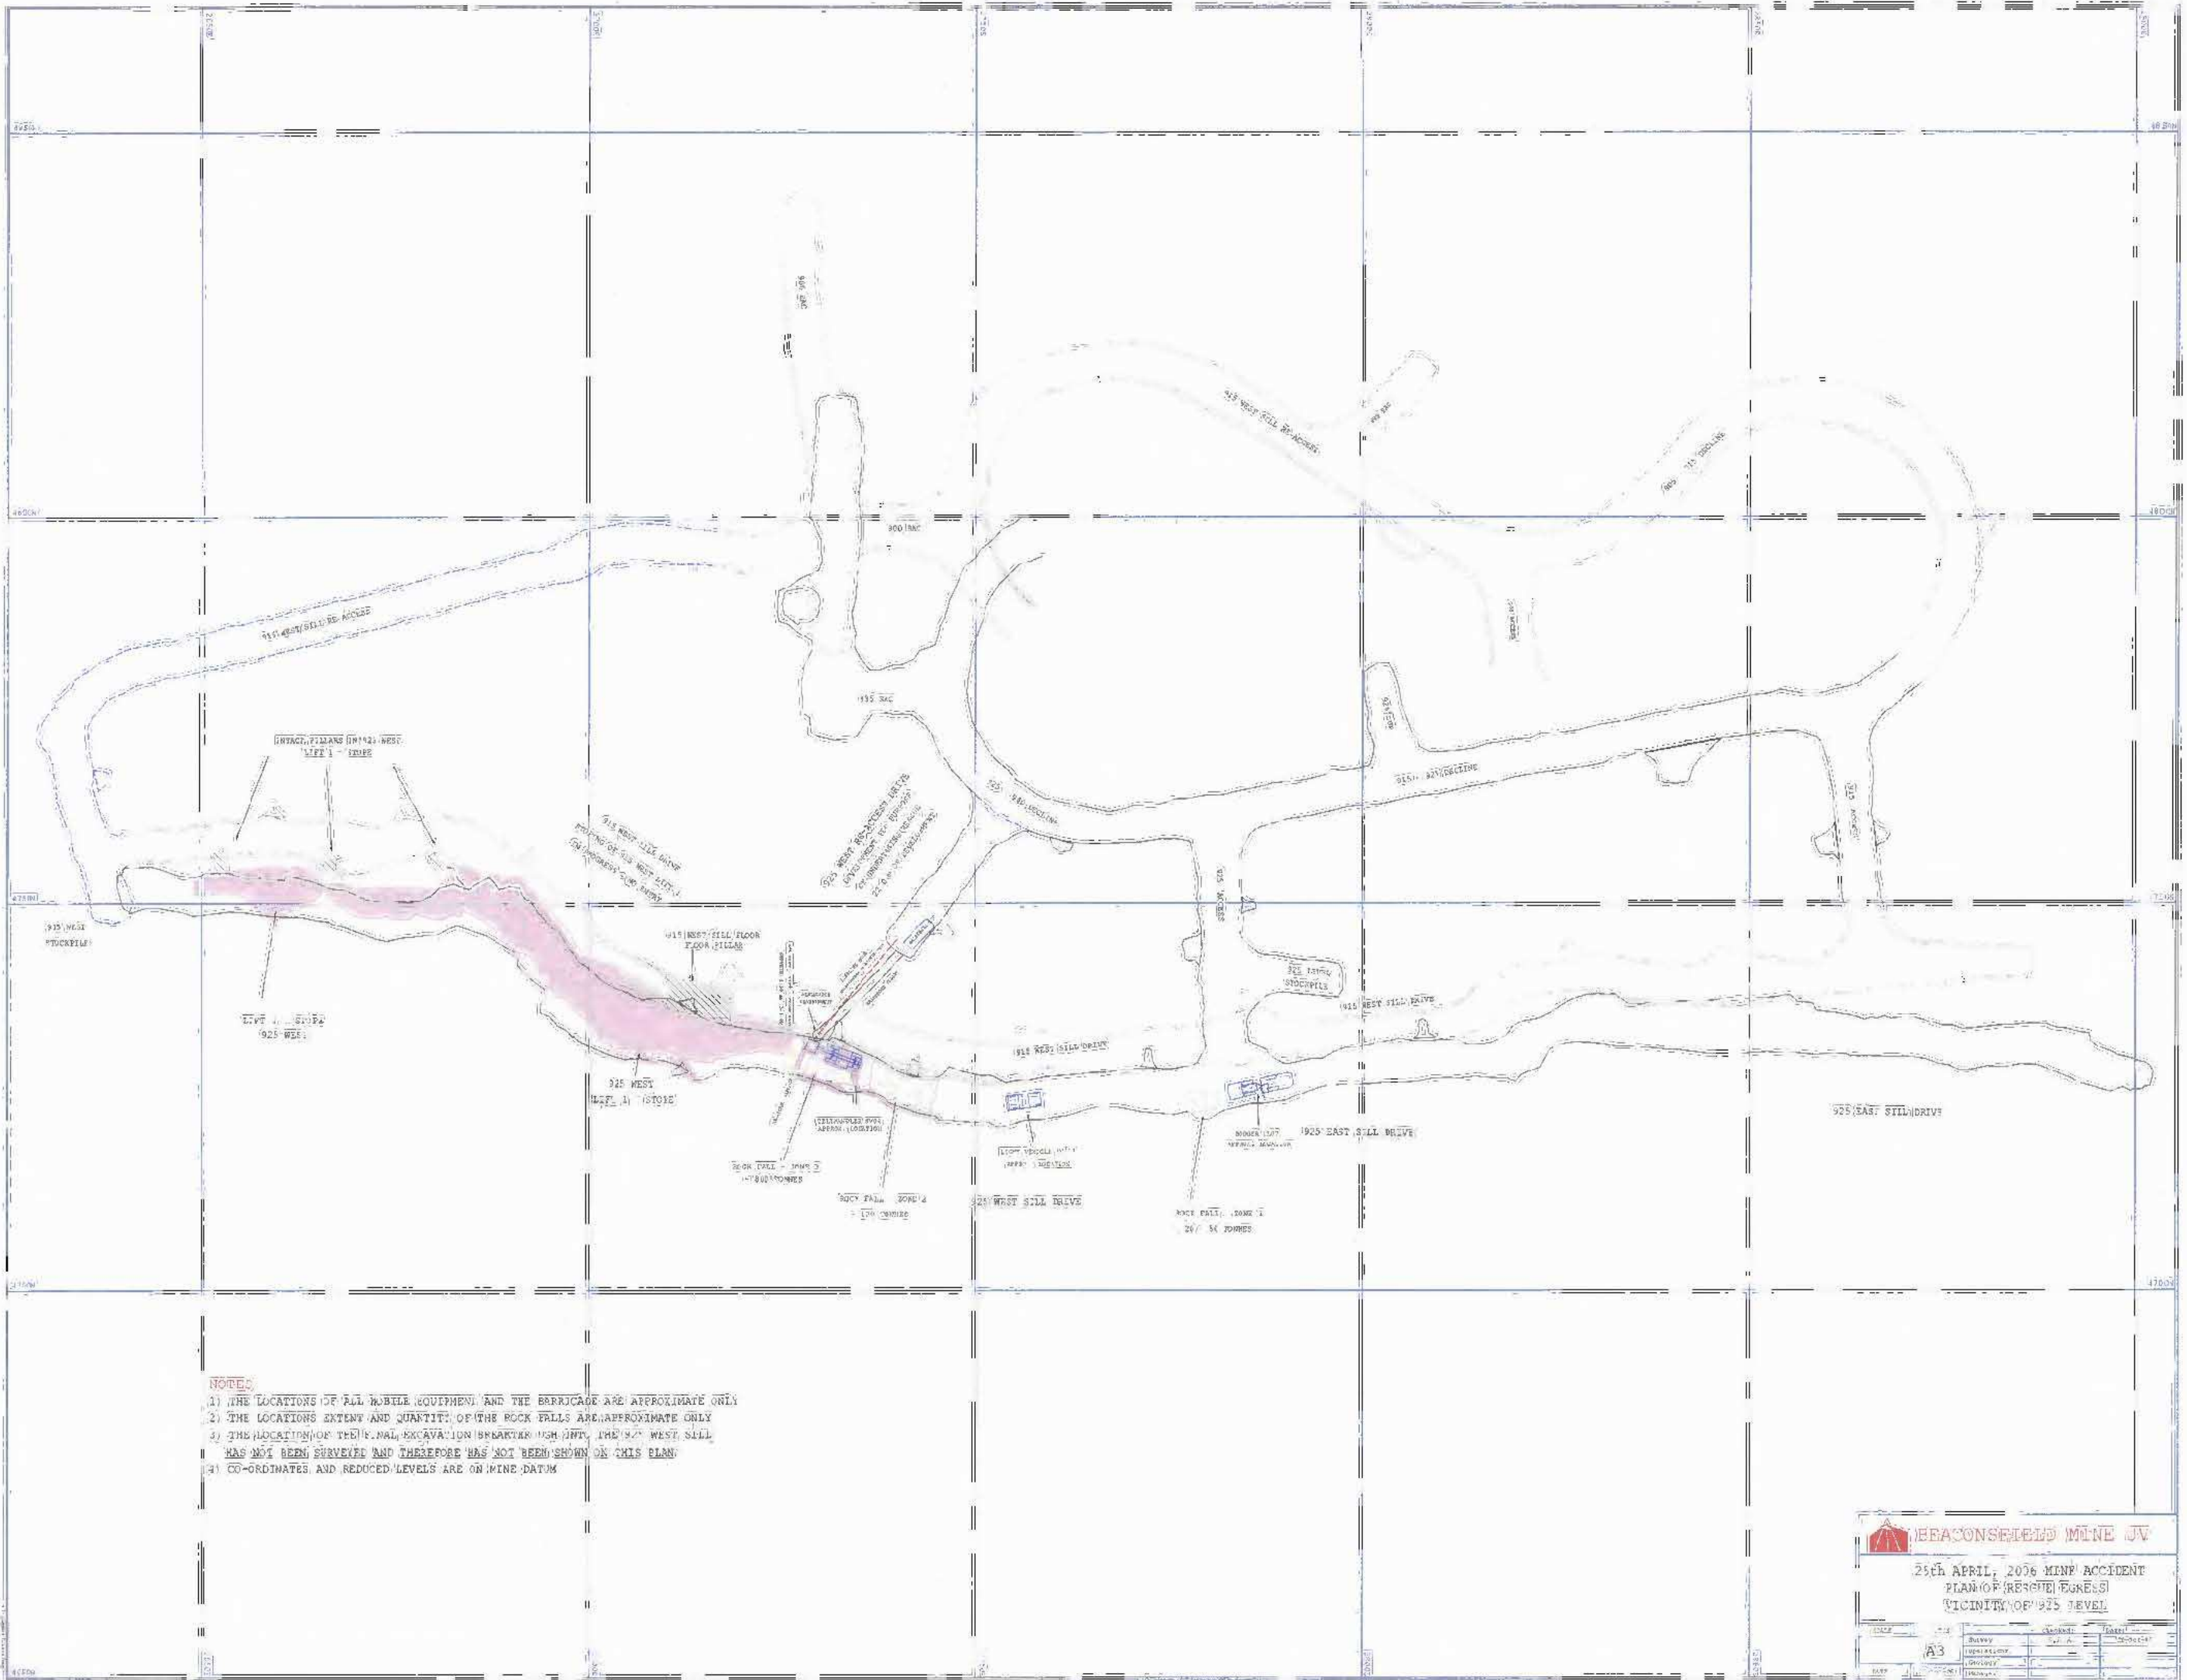
Figure 14

On 25th April 2006, Messrs Knight, Russell and Webb were allocated the task of placing netting at the brow of the remains of the eastern edge of panel 10 to allow the placing of rock fill from the 915 west sill on to the 925 west sill. Figure 13 shows a long section of the operation immediately prior to the rock fall. Messrs Russell and Webb were in a basket at the front of the telehandler which was being operated by Larry Knight. Immediately prior to the rock fall, Mr Knight had lowered the cage onto the rock bund and had left the telehandler to collect some mesh. An overhead plan of the same position is shown at Figure 14. At 9.23 pm there was a seismic event of approximately 2.3 magnitude level, which caused rock falls on both the 925 and 915 levels. Figure 15 is a long section of the mine showing the position of those rock falls and Figure 16 and Figure 17 show overhead plans of the position of the rock falls. Also shown on Figures 16 and 17 is the position of the raise bore tunnel which was drilled to allow the rescue of Messrs Russell and Webb.

It would appear that Mr Knight was trapped under the fall of ground immediately behind

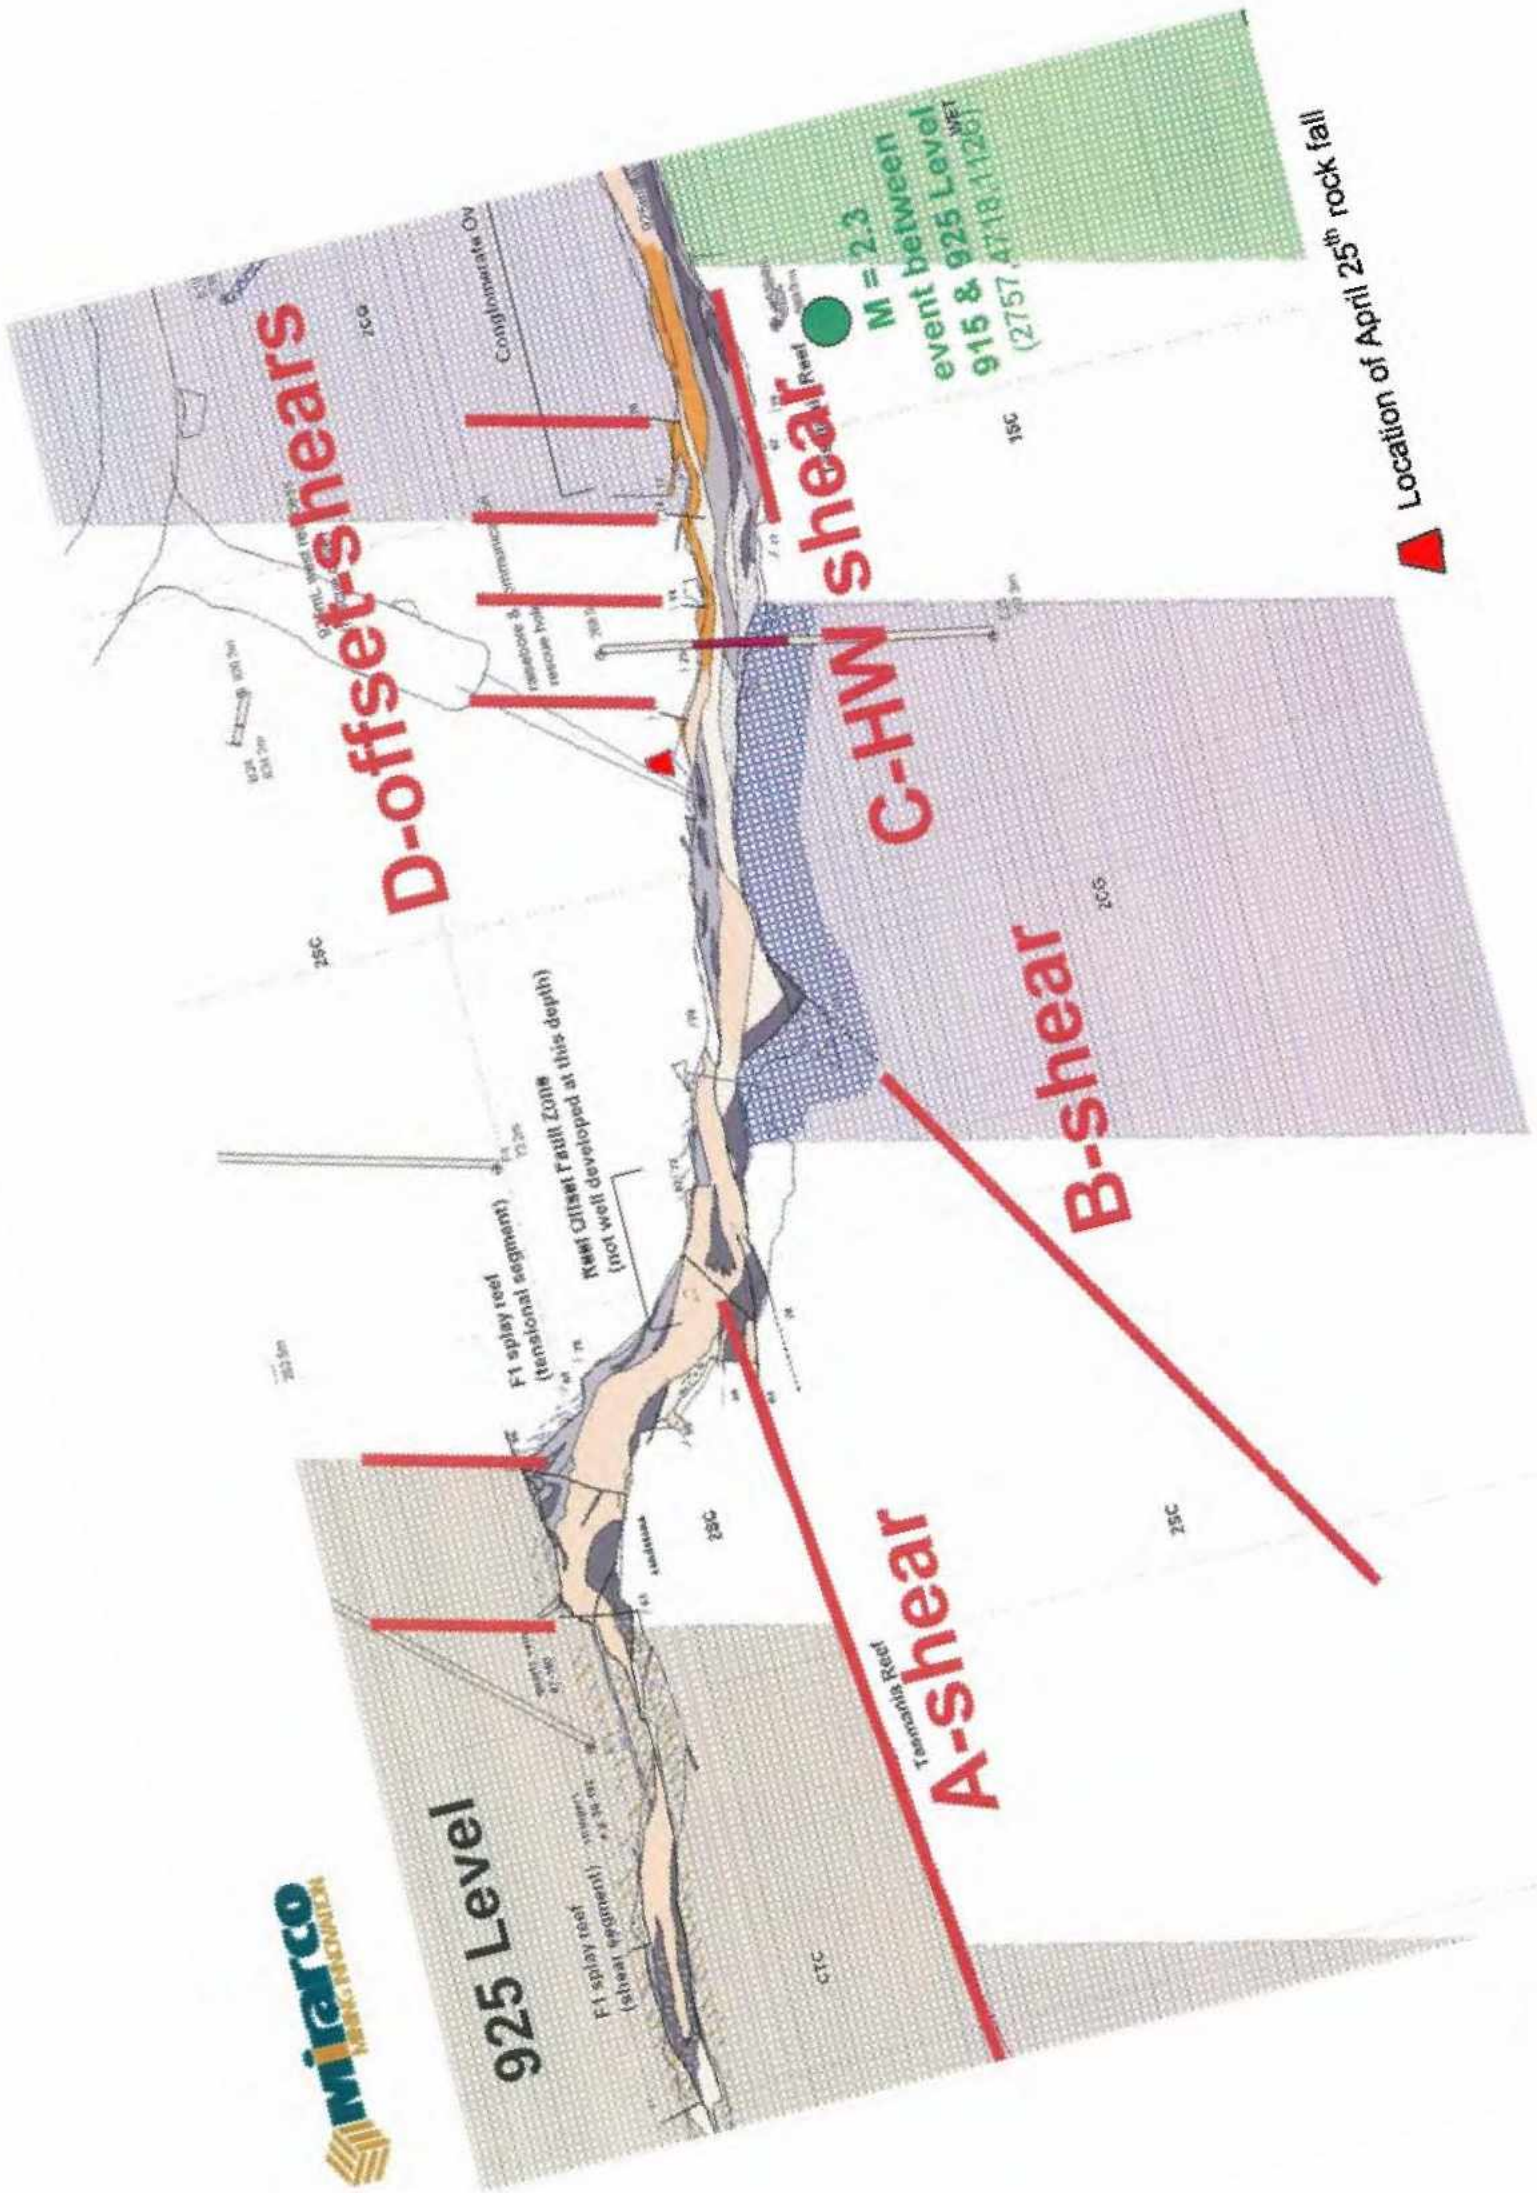
M = 2.3
event between 915 & 925 Level
WET
(2757.4718, 1126)

Location of April 25th rock fall

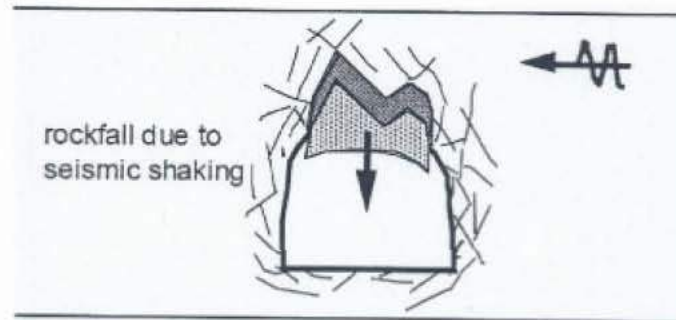
Figure 19 Schematic diagram showing the interpreted mechanism (Kaiser et al 1996)

The main 925L and associated rockfalls were due to seismic shaking caused by the 2.3ML event. This sudden increase in energy was sufficient to exceed the capacity of the installed ground support at the rockfall locations.
