BEACONSFIELD INVESTIGATION REPORT

Concerning the Incident Resulting in

The Death of Larry Knight

Which occurred at the Beaconsfield Mine

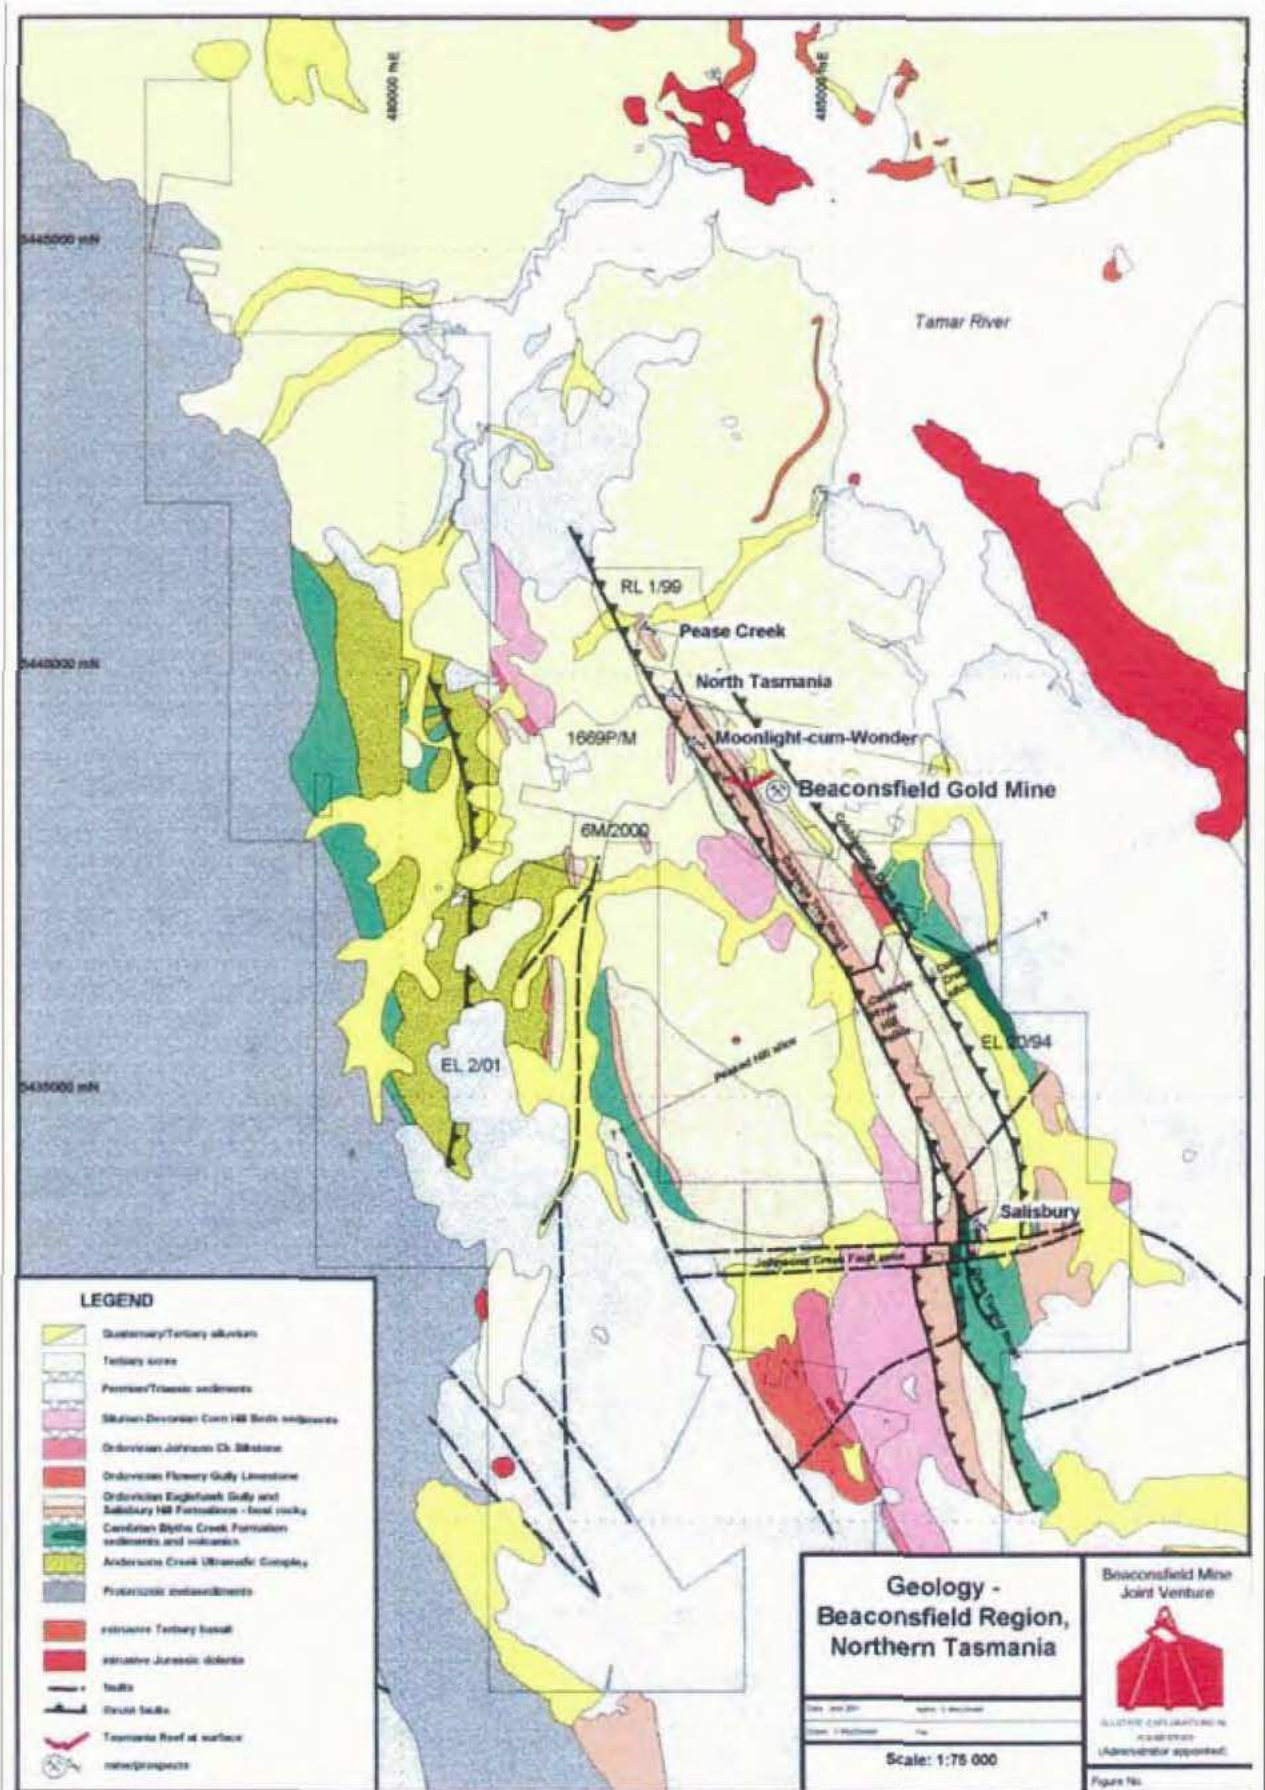
Figure 01

Figure 1 shows that the pre-Permian geology of the Beaconsfield Region outcrops as a series of north northwest-striking, east dipping imbricate thrust slices. From west to east the slices are the Peaked Hill slice, the Cabbage Tree slice and the Cobblestone Creek slice. Each of these are bounded to the west by thrusts of the same name. The rocks unconformably overlie the Anderson's Creek Ultramafic Complex.

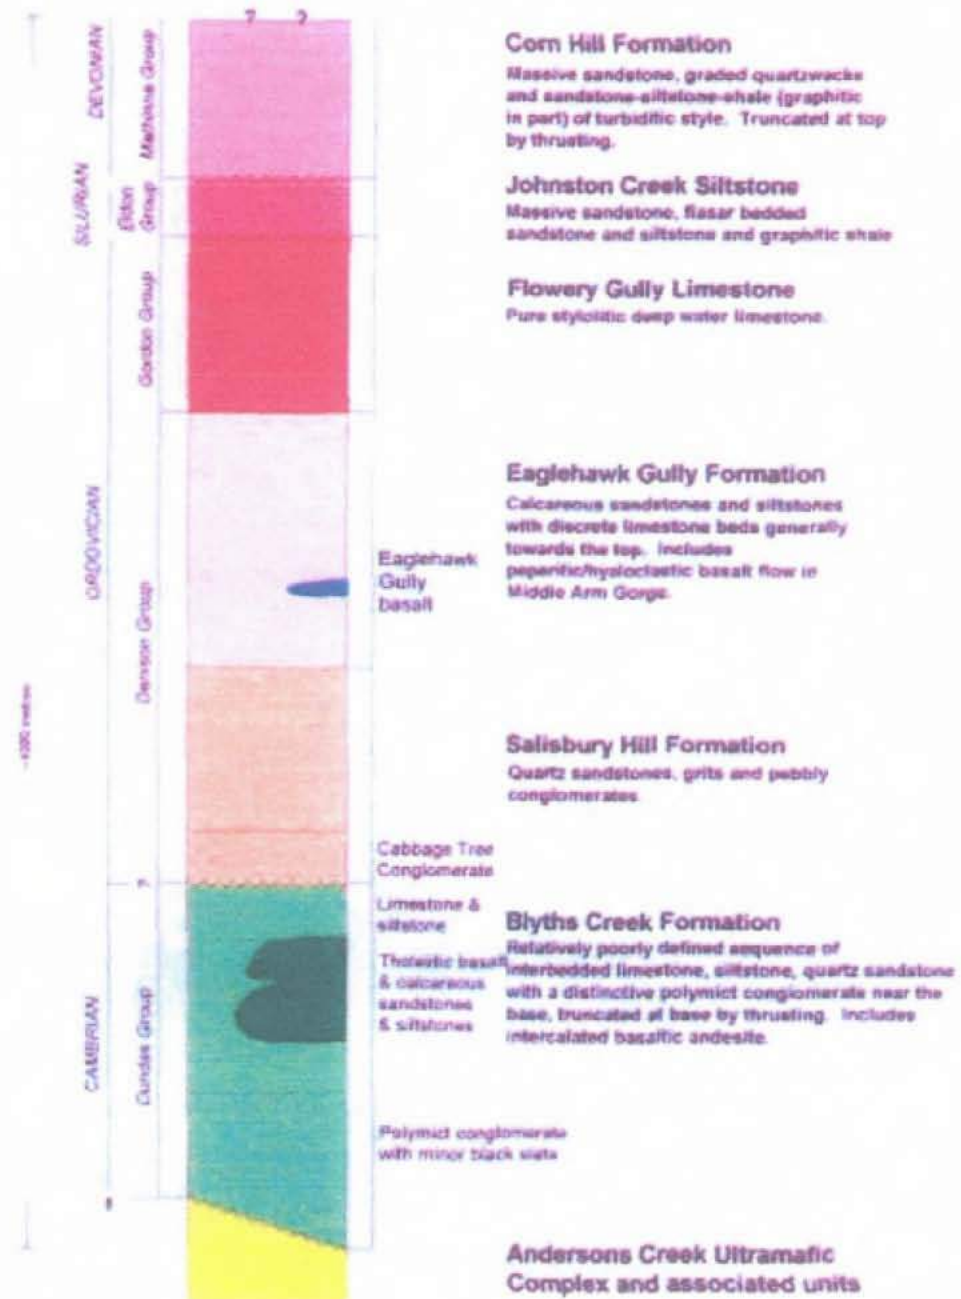
Figure 02

The lower to middle Palaeozoic stratigraphy (see Figure 2) crops out in a relatively narrow 6km wide belt stretching around 20km from Pease Creek, 3km north of Beaconsfield to Reids Creek near Biralee. Overall, the structure of the Beaconsfield district is dominated by faulting. Faulting is more common in southern parts of the Beaconsfield district, but is everywhere associated with thrusts. The deposit formed along a Devonian-aged dilational fault within siliciclastic-calcareous rocks correlated with the Dundas, Denison, Gordon, Eldon and Mathinna Groups.

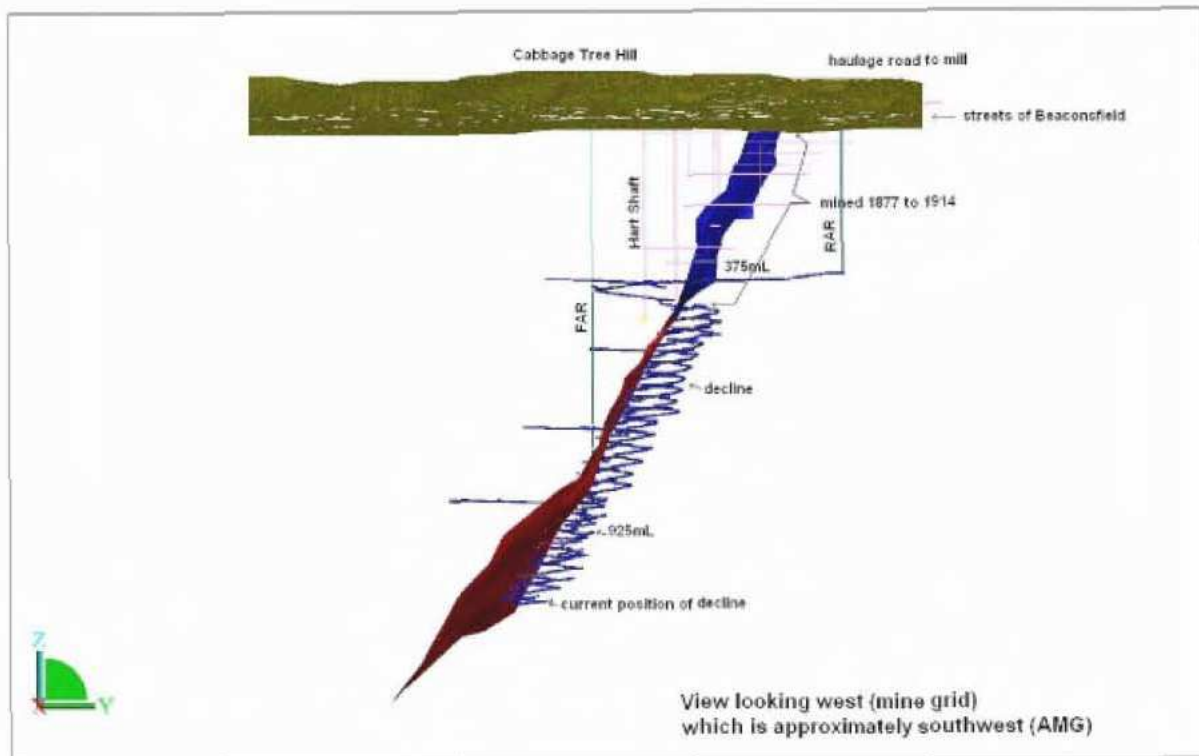
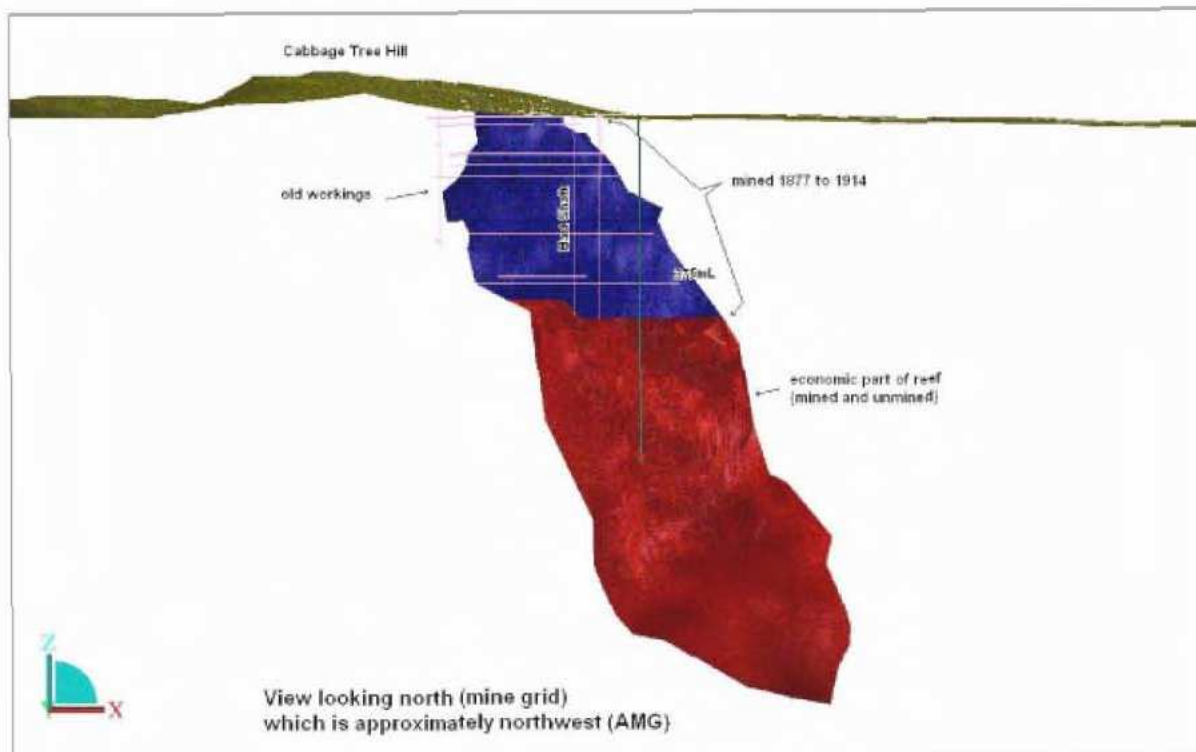
Figure 03 and Figure 04

Figure 3 shows the orientation of the ore body with a depth of 1100 metres and an average thickness of 2.6 metres. - The thickness varies from about 0.2 to 8 metres and is approximately 4 – 5 metres on many of the mining levels. Also shown to the right of the

ore body is the decline from which access is gained to the ore body. The decline is mined through waste rock and is ground supported by the use of split sets, strap and mesh, with shotcreting and cable bolting in some parts. It is wide enough to accommodate the free movement of heavy mining vehicles.

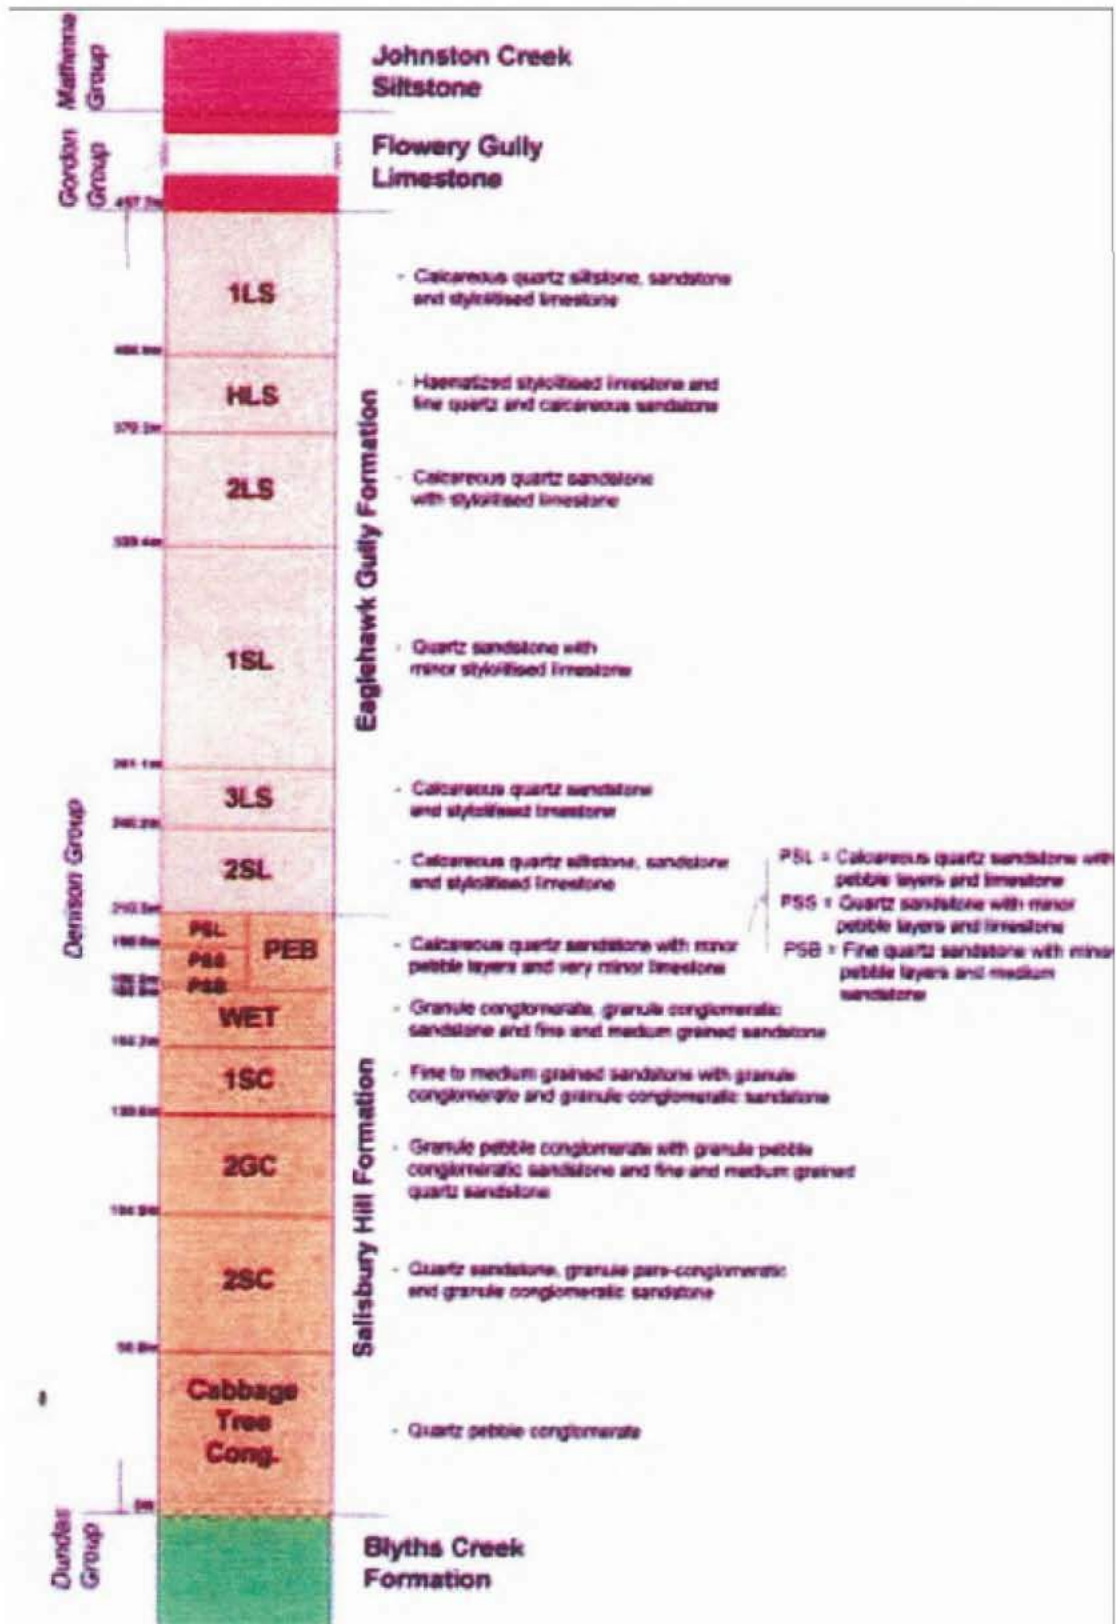
Figure 05: Mine Stratigraphy Beaconsfield

Lewis (1998) formalised the stratigraphy (see Figure 5) of the Denison Group correlates at the Beaconsfield Gold Mine and recognised two formations, the Salisbury Hill Formation and the Eaglehawk Gully Formation for the units historically referred to as the Lower and Upper Transition beds respectively.

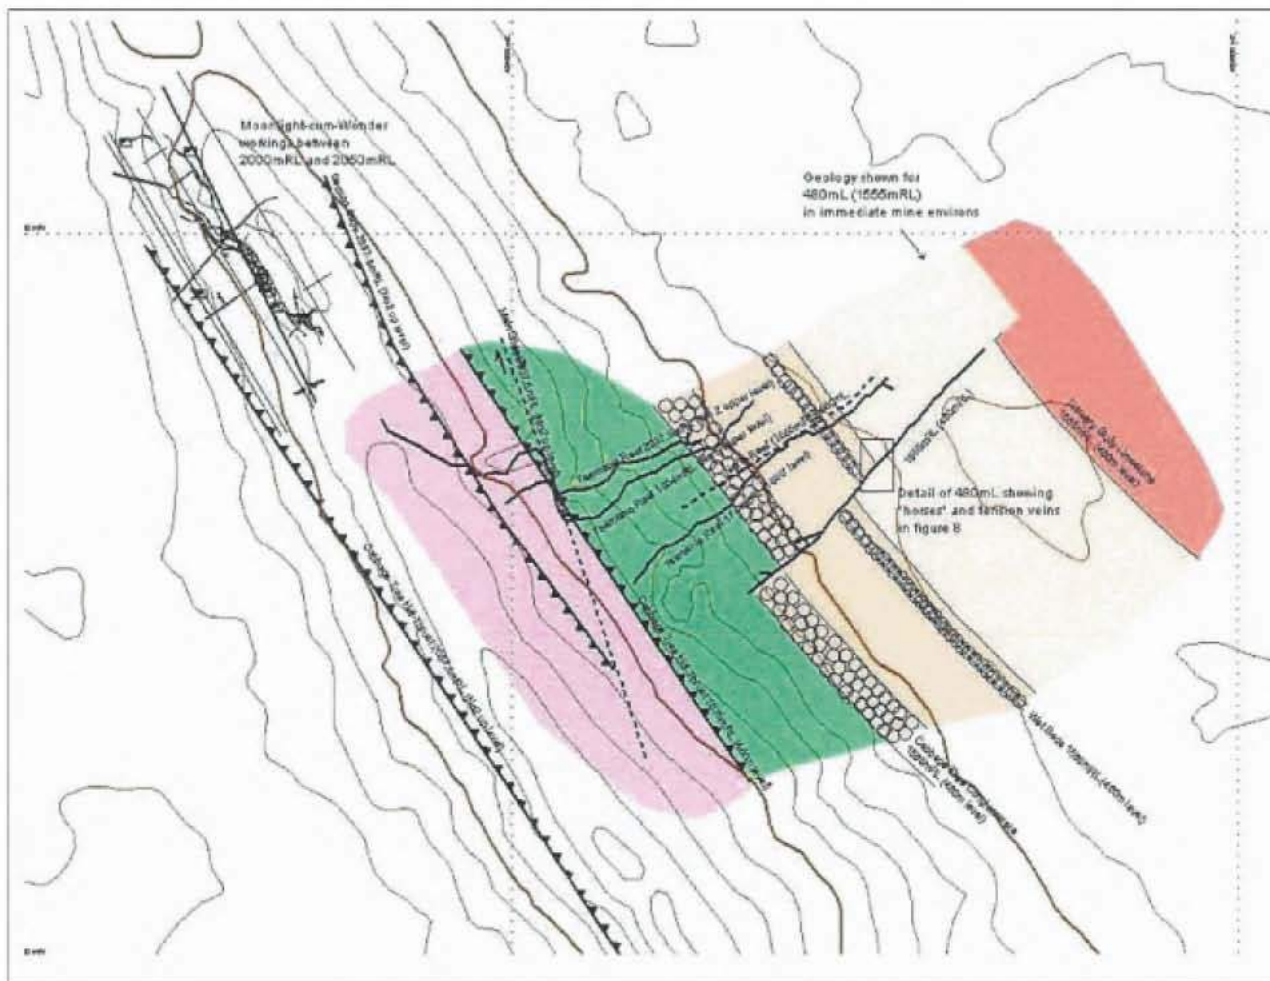
Figure 06 – Plan of the Tasmania Reef and Associated Structures

Overall, the reef averages 2.6m in width ranging from a minimum of 0.5m to a maximum of 8m. Zones of above average width generally occur at the intersections of splays and bifurcations. Mining in the late 1990s demonstrated that the reef pinches and swells down plunge and along strike.

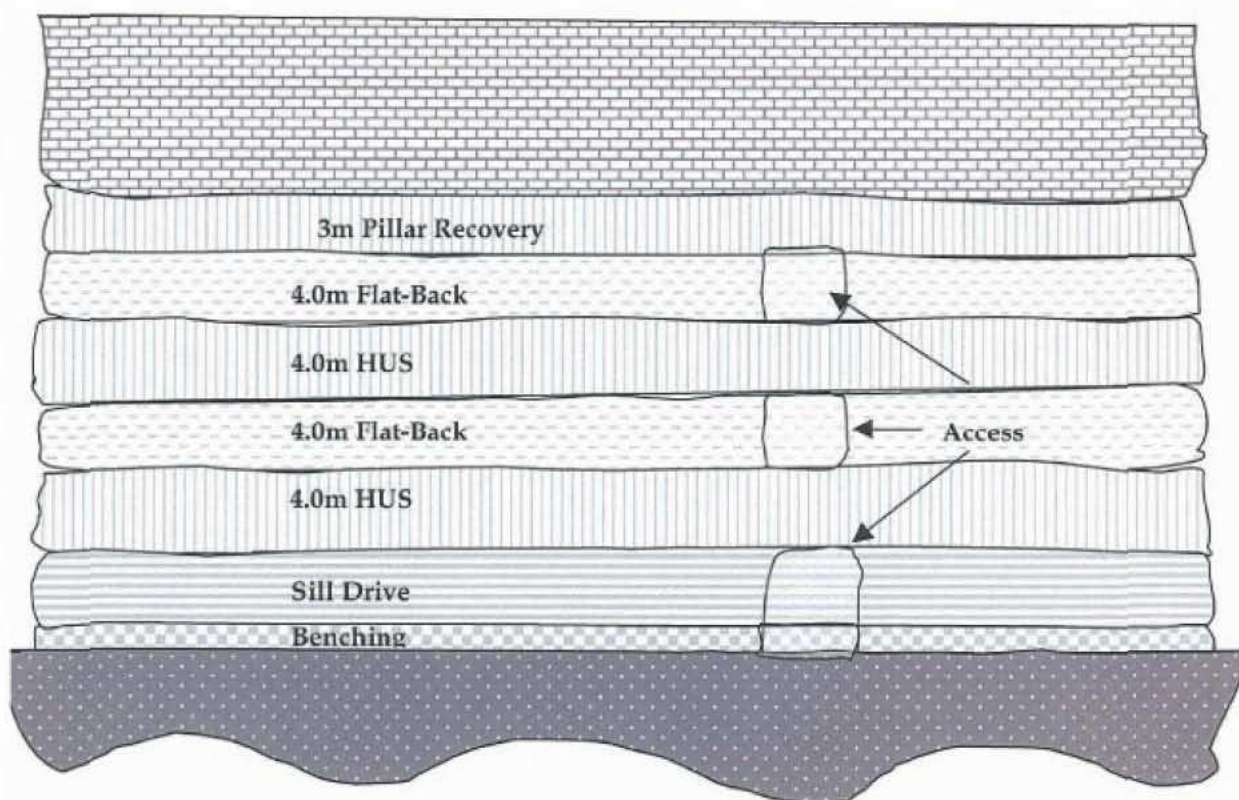
Figure 08: Layout of HUS Method

The layout of the HUS mining (which was used in the upper levels) is shown schematically in Figure 15. Following development of a sill drive along the reef the floor is benched down 2m starting from the access ramp into the stope. The void created by the benching is then filled with cemented rock fill. Once the stope has been filled, detailed geological cross-sections were used by the mining department to produce blasthole ring designs. Ring positions were marked up and a four metre slot rise is established at the extremities of the stope. Up holes of 51mm diameter were drilled using a jumbo based on the ring plans to ensure that potential damage to the hanging-wall from blasting is minimised. Holes were charged with ANFO/Isanol using None1 detonators and blasted up to several rings at a time depending on ground conditions, stope width and production requirements. Ore was bogged remotely and hauled to a stockpile. After final clean up the stope was tight filled with a combination of waste rock and hydraulic fill. The ramp is then stripped so that the floor of the ramp is at the design level of the stope backs and a 4.0m high flat back lift above the fill is taken over the length of the stope. The cycle is repeated three times until there is a seven metre crown pillar between the backs of the stope and the CW sill pillar on the level above. The crown pillar (3m high) is then removed by HUS, starting from the end of the stope and working back to the access.

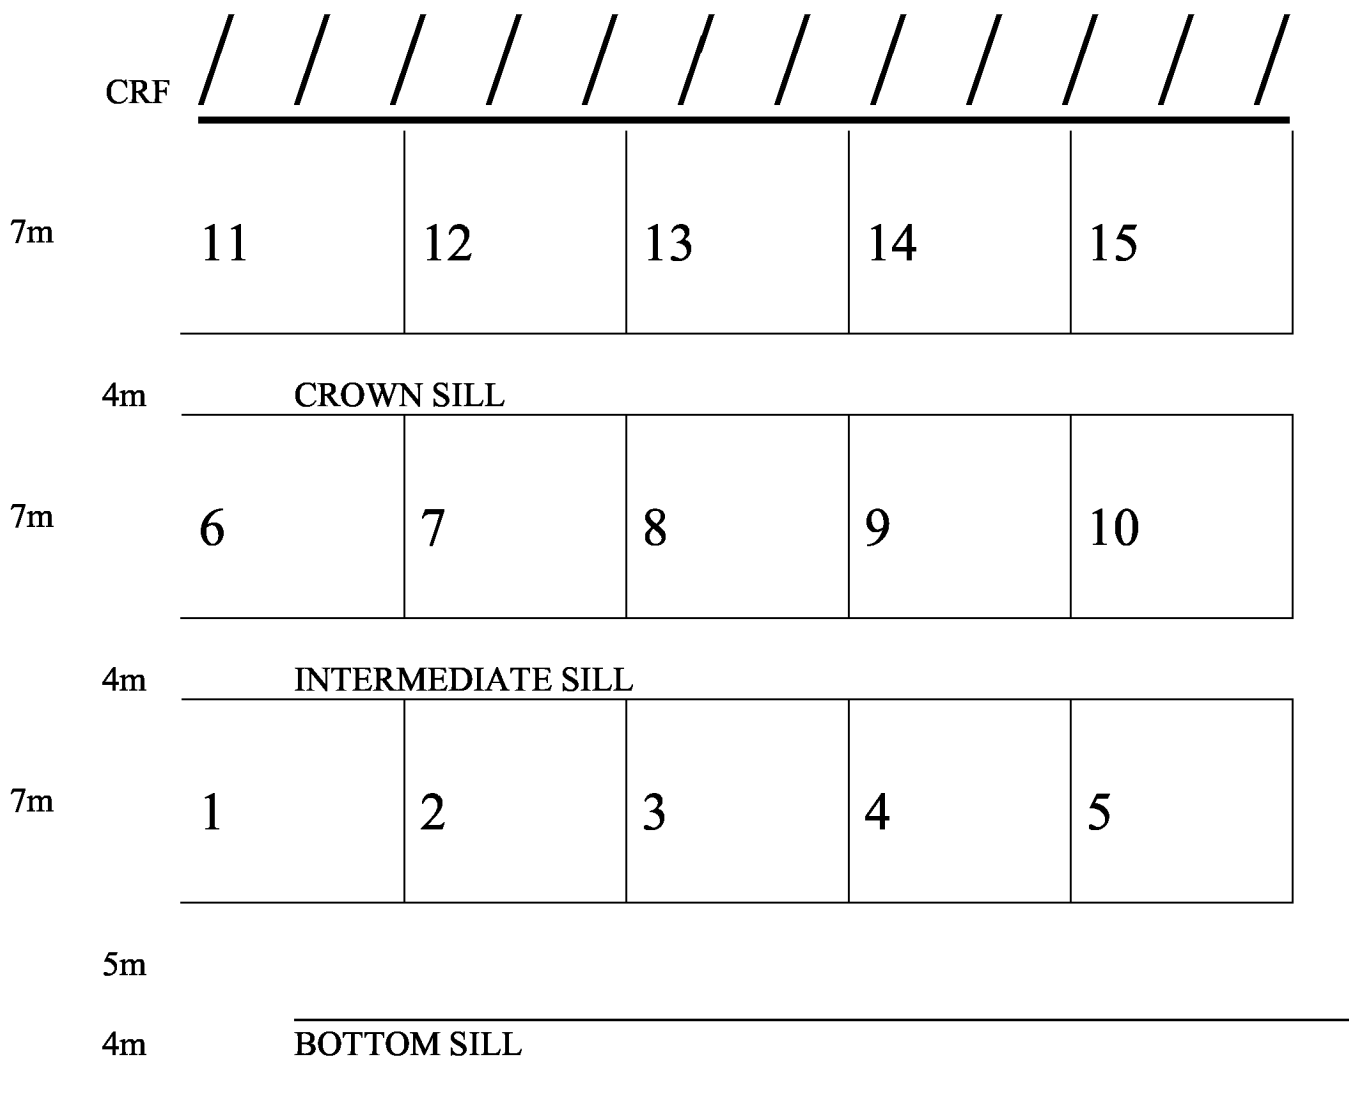
Figure 10

The figure above indicates a typical mining sequence using the Modified Avoca Method. Upon the completion of the sill drives, which could be up to approximately 175m in length, “half uppers” of 5m in height would be blasted above the bottom sill, by placing charges in the backs (roof) of the bottom sill, panel by panel and retreat mining towards the access drive.

As each panel is blasted the ground support is destroyed and therefore the ore deposited on the ground is removed towards the access drive by remote boggers. From there, the ore is taken up the access drive to be treated. Once the 5m level above the bottom sill has been mined, ground support is placed in the backs of that level and cemented rockfill (CRF) is placed along the bottom sill to a height of 5m. This CRF will effectively become the roof of the mining block below, as well as a platform from which to commence blasting the stopes above.

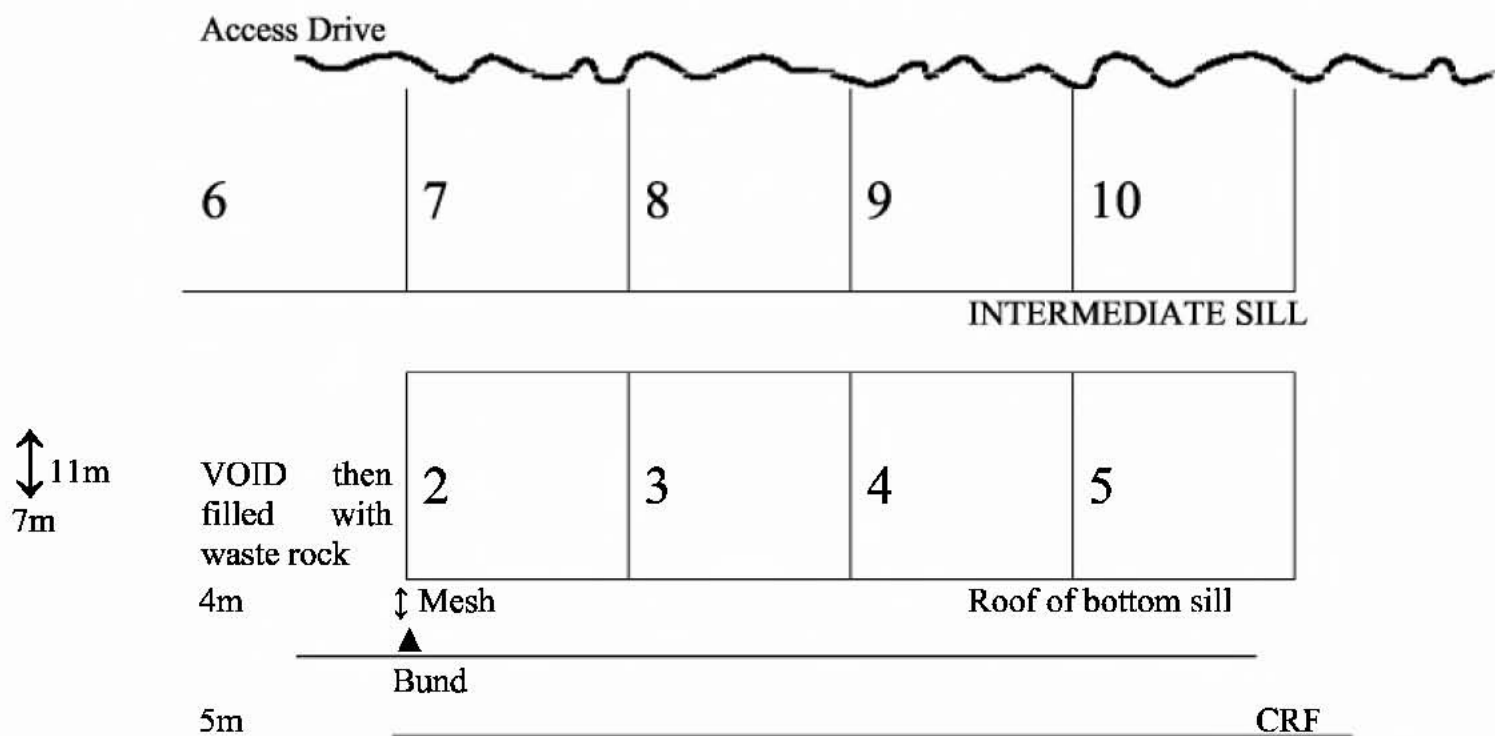
Figure 11

Miners would then move to the edge of the void and place a ‘bund’ at the limit of the ground support where wire mesh would be set up to prevent waste rock due to be inserted into the void, spilling in to the working area. (It was this type of procedure that was being performed by Messrs Knight, Russell and Webb when the accident of 25th April 2006 occurred.) Once the mesh was in place, waste would then be transported along the intermediate sill and filled level with the base of the intermediate sill to allow later access to panel 6 above.

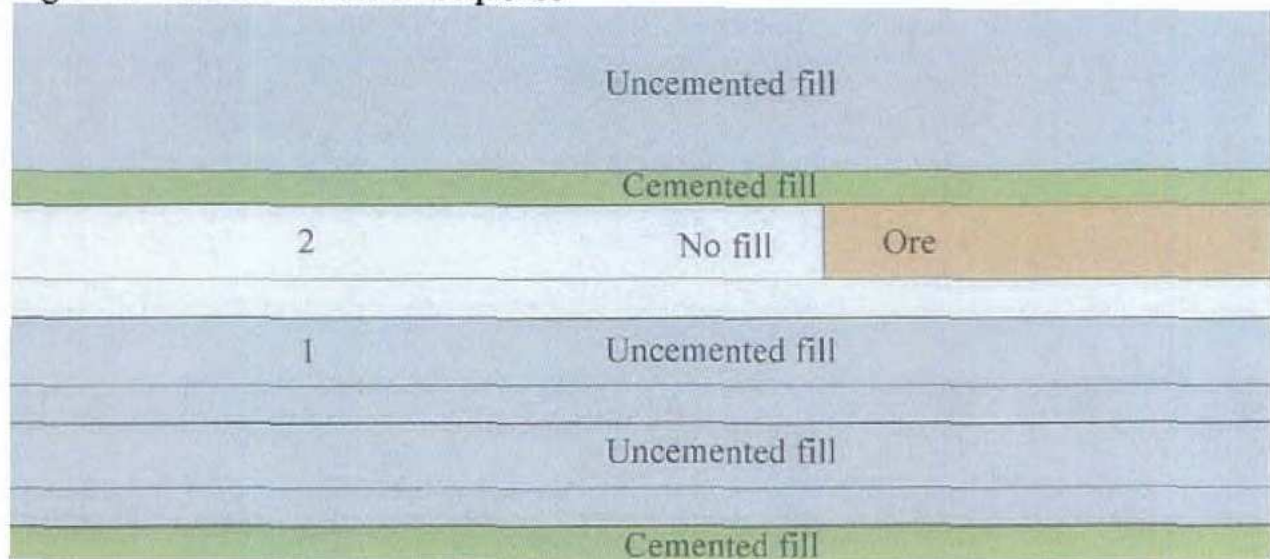
Figure 1.1 Current Extraction Sequence

Factor 1 and 2 change as stopping progresses downwards, due to the complex geological environment – changes in the folding axis of the reef horizon, changing conglomerate overlap zones, and mineralised Off-set Fault changes in relation to the reef horizon. When combinations of the above factors are encountered simultaneously, an even higher hazard could be expected during stopping operations.
